POTTERY OF TROY VIIB

CHRONOLOGY, CLASSIFICATION, CONTEXT AND IMPLICATIONS OF TROJAN CERAMIC ASSEMBLAGES IN THE LATE BRONZE AGE/EARLY IRON AGE TRANSITION

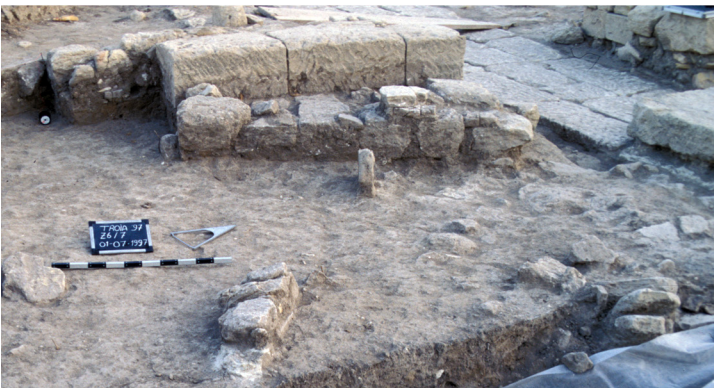
B. Part of the division wall between North House A and North House B shortly after its discovery. On top of it large rectangular blocks of Troy VIII wall. On the right the foundations of Hellenistic Temple A. (Dia 28920)

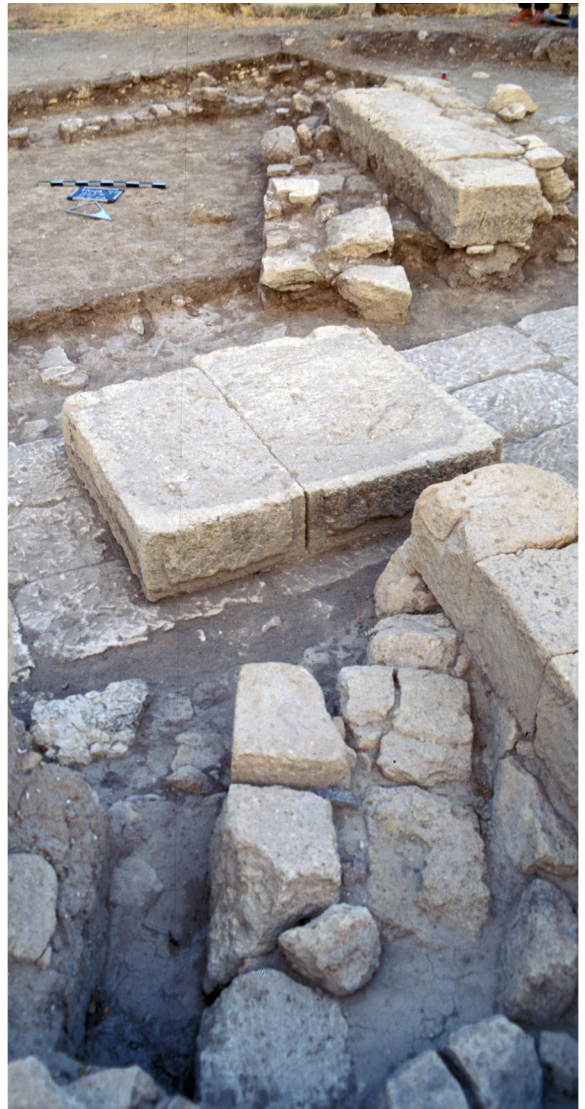
C. Division wall between North House A and North House B (running vertically in the middle) disturbed by foundations of the Hellenistic Temple A. (Dia 28914)

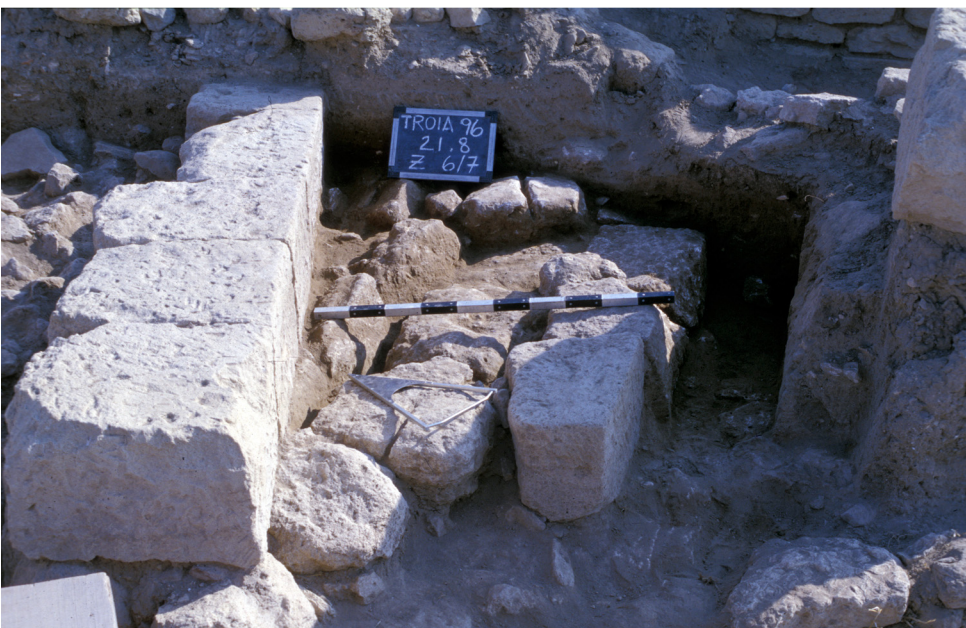
D. Division wall between North House A and North House B superposed by an Archaic Wall (on the left). (Dia 25322)

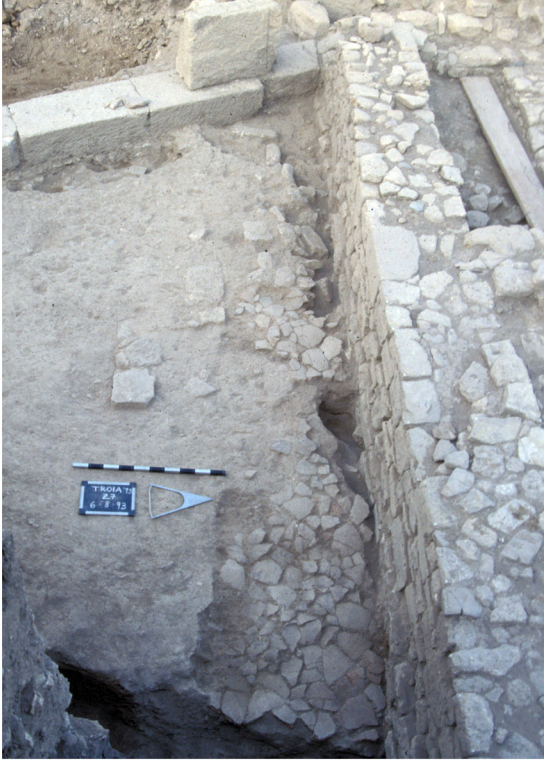
A. Pavement of broken tiles and pithos sherds (Hellenistic?) covering the Vertical stones feature 1. (Dia 13501)

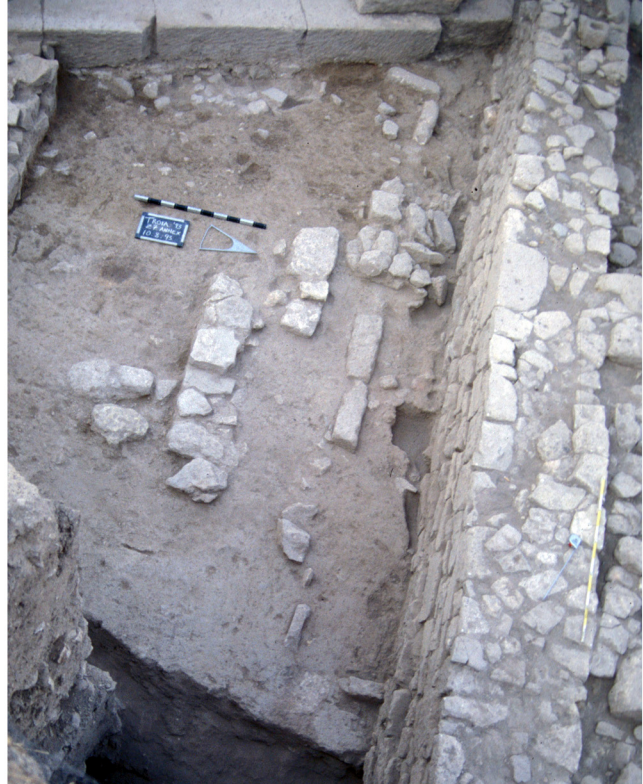
B. Vertical stones feature 1, North House A and the Crosswall (Dia 13504)

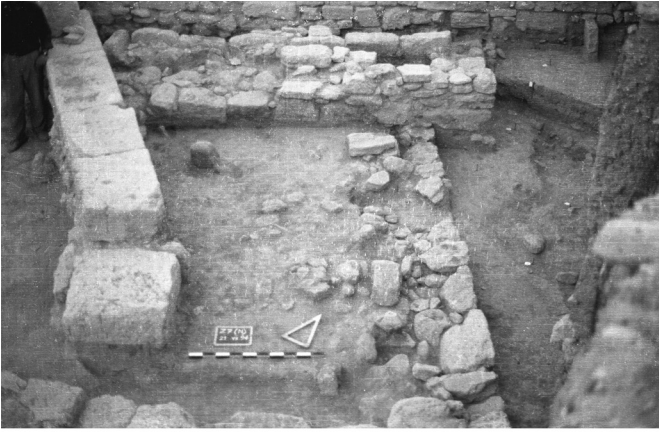
A. Deposits covering Room 5 of the Terrace House (in the middle). North House A (top middle) and Hellenistic Wall (on the left). SW 94/27/22.

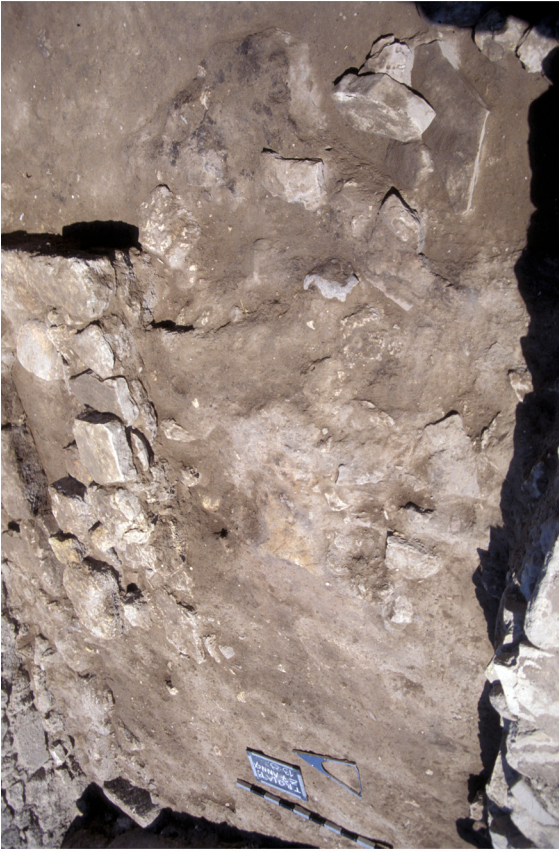
A. Southeast corner of the North House A and the burnt debris next to it (Dia 13531)

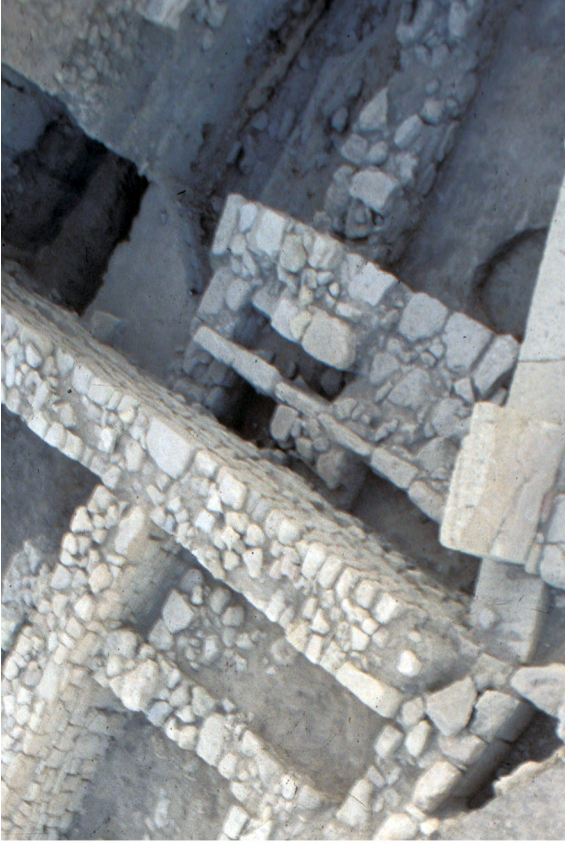
B. North House A, Vertical Stones Feature 1, the Crosswall and the Pit with restored vessels (bottom, middle). View from the southwest (Dia 16617)

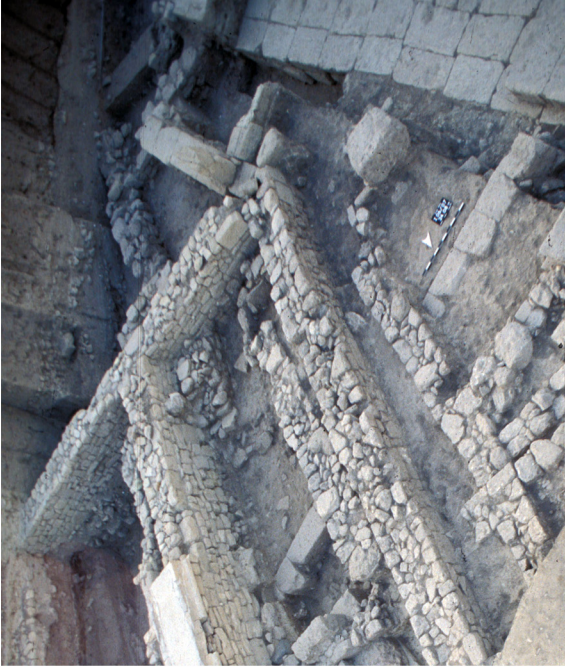
B. Vertical Stones Feature 2 and the continuation of the Cross-wall in the corners of Hellenistic foundations (Dia 16665)

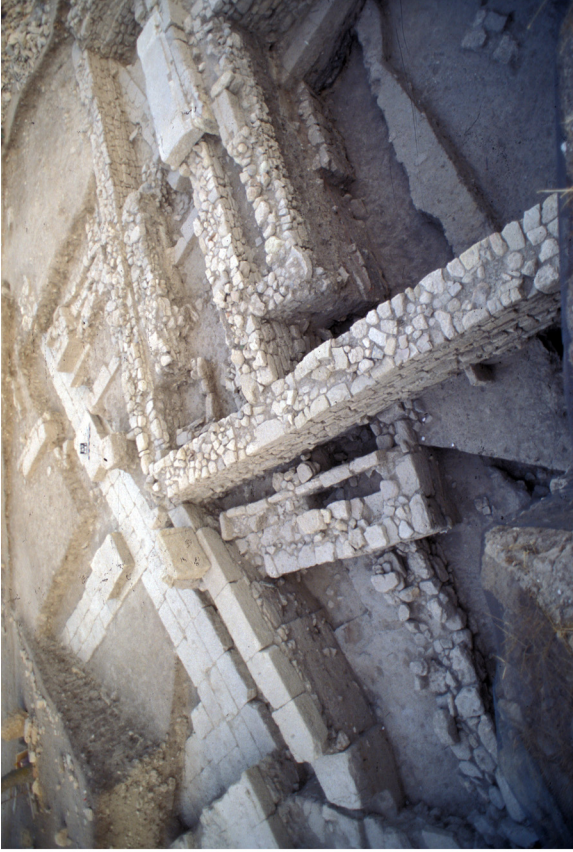
A. Vertical Stones Feature 1 (in the middle) and Vertical Stone Feature 2 (in the corner of the Hellenistic foundations). (Dia 16654)

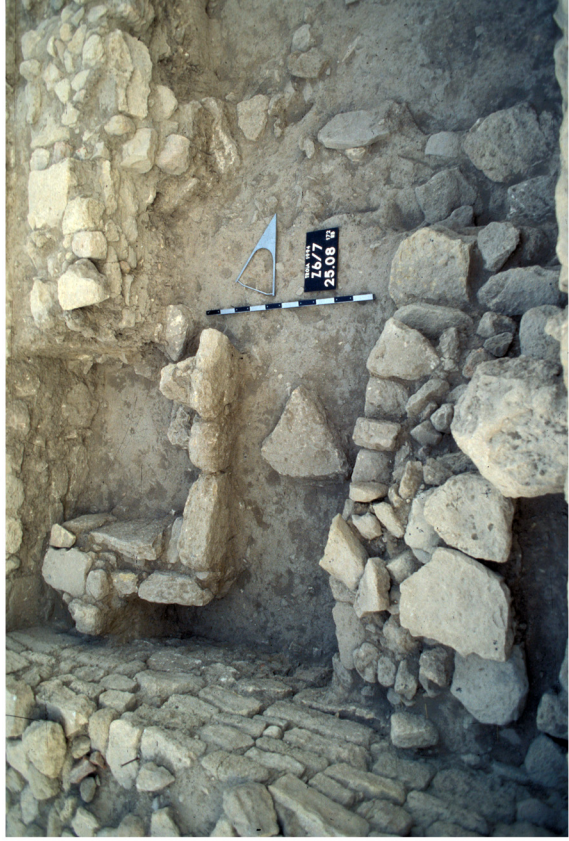
D. The continuation of the Crosswall (foreground) and the Vertical Stones Feature 2 (background). (Dia 16673)

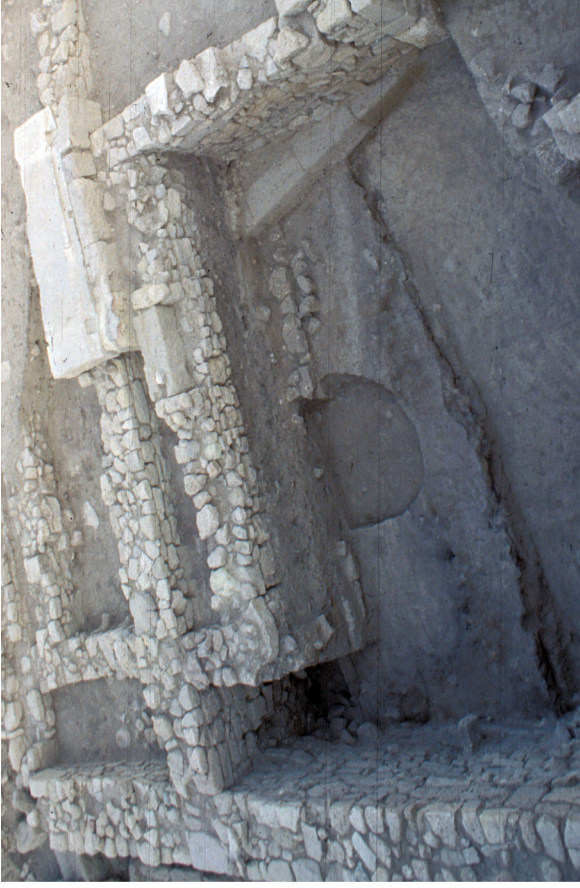
B. North House B in its southeastern part disturbed by the Geometric pit. Both deep under the Hellenistic foundations. In the lower part: 4th century BC long cut. (Dia 16619)

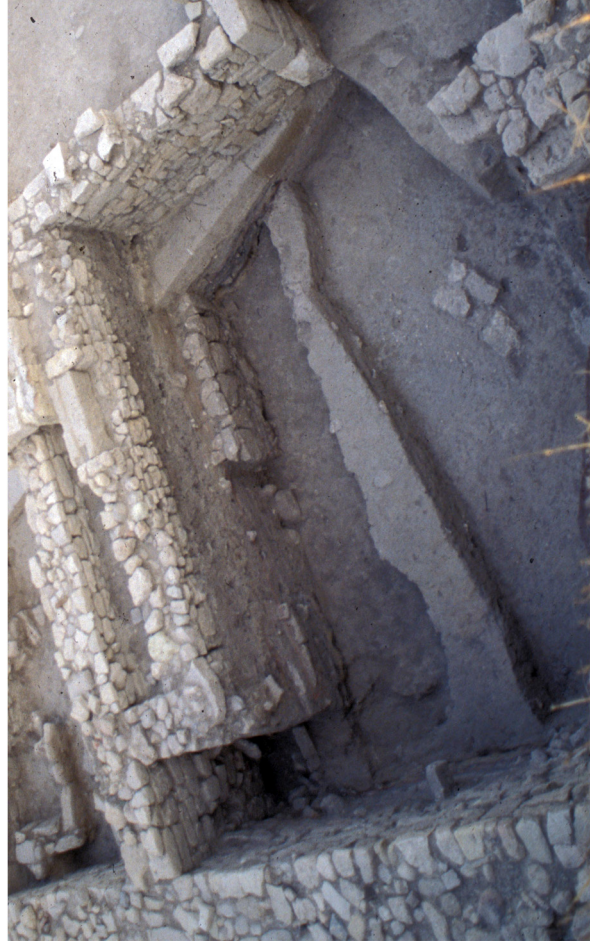
C. North House B in its southeastern part. Above it an Archaic boundary wall (ashlar blocks deep on the right) and various Hellenistic walls. (Dia 20205)

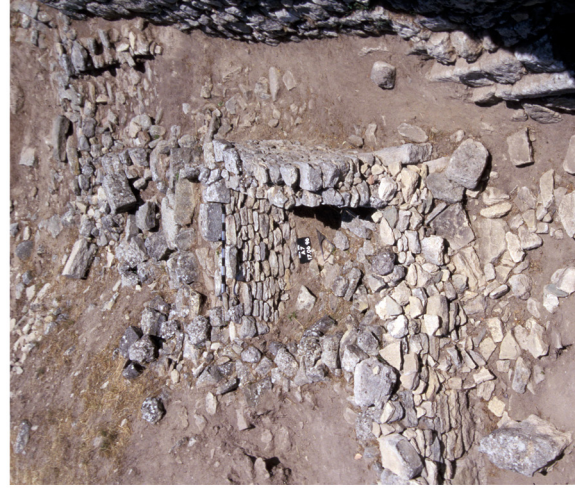
D. Southeast part of House 791 as found after the removal of vegetation. (Dia 23983)

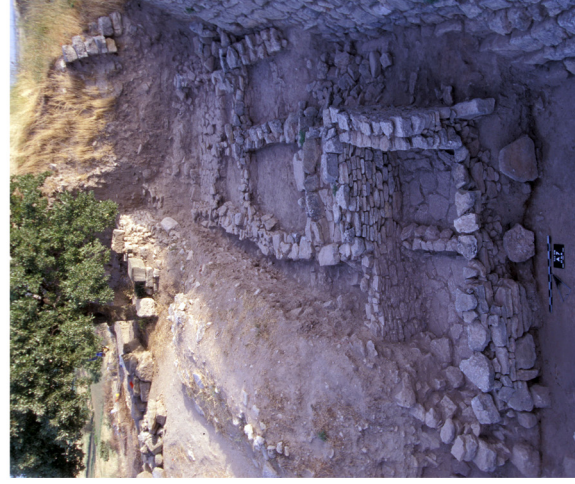
E. House 791 after the cleaning. (Dia 23993)

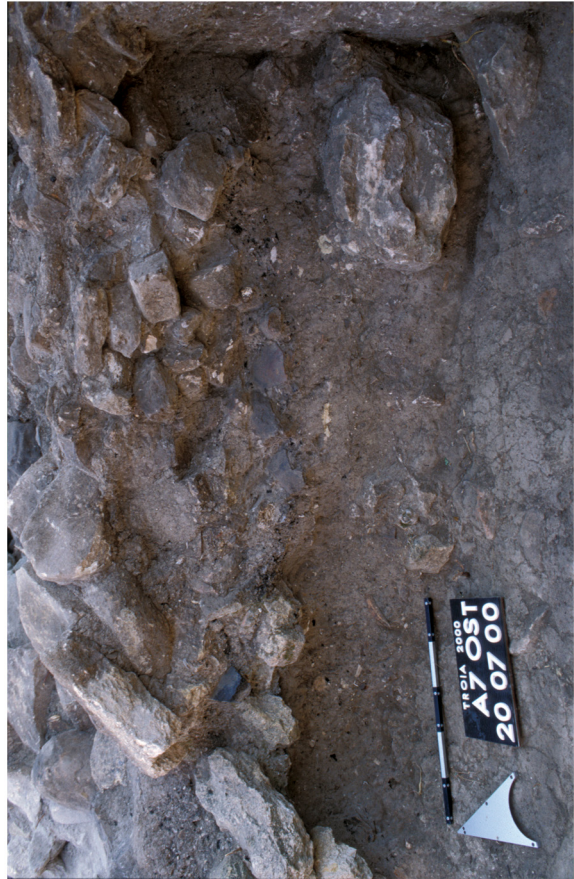
C. Debris with stone collapse, burnt matter and broken pottery under the Geometric Terrace wall. (Dia 43628)

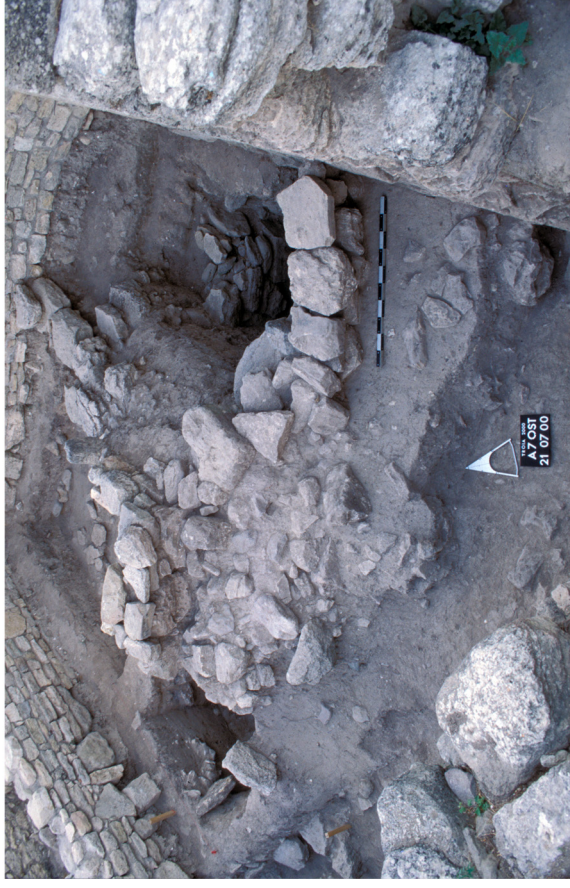
D. House 792 (middle) and House 792 Annex (right, above the scale meter) after the removal of debris with burnt matter and broken pottery accumulated in front of the Annex. (Dia 43630)

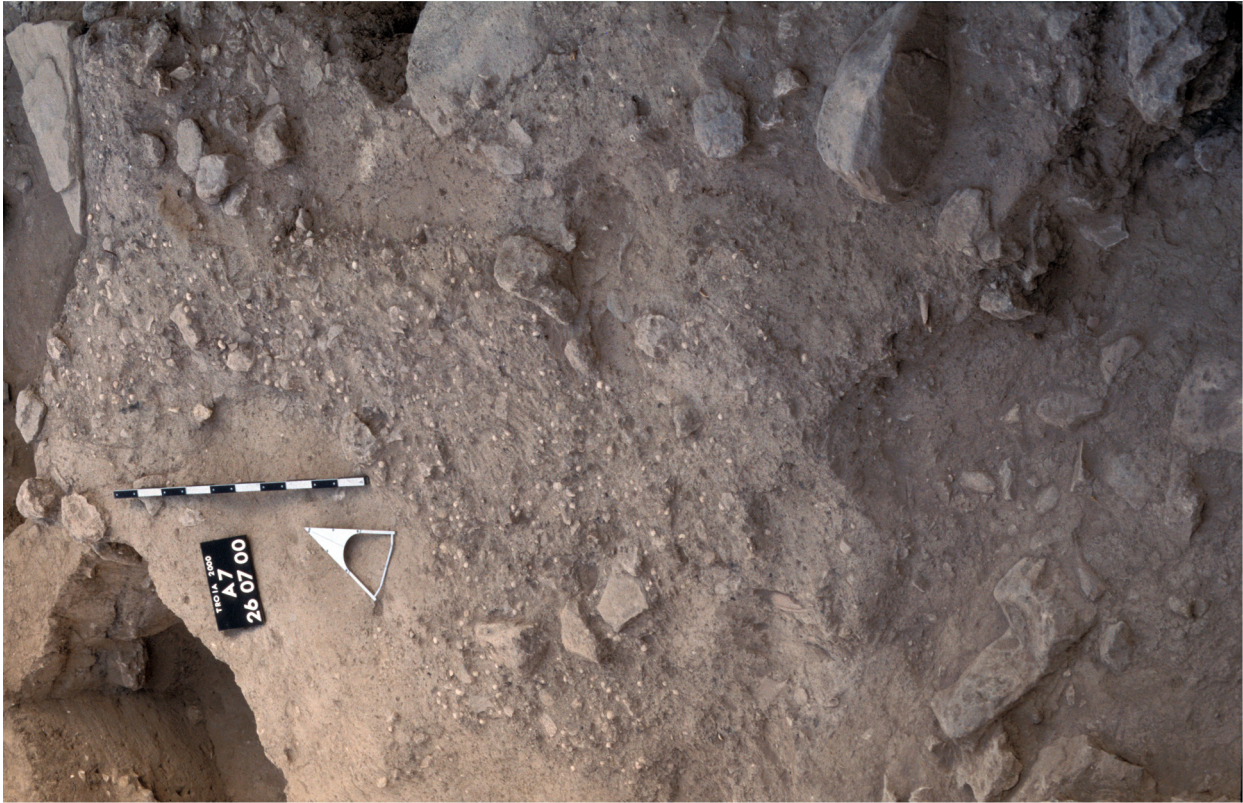
A. Shell layer. In the foreground a not emptied part of earlier Dörpfeld sounding, in the background left an emptied earlier sounding. In the right background a wall of Troy VI shows through. (Dia 43639)

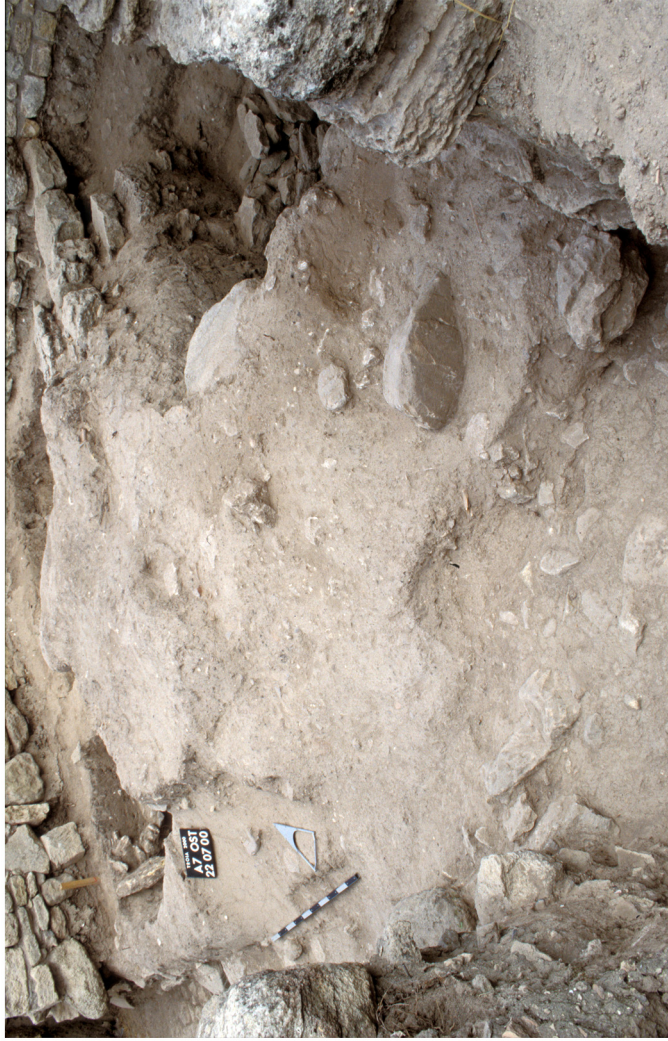
B. Situation above the shell layer, below the House 792 and its Annex. Burnt layer visible in higher parts in the middle. (Dia 43638)

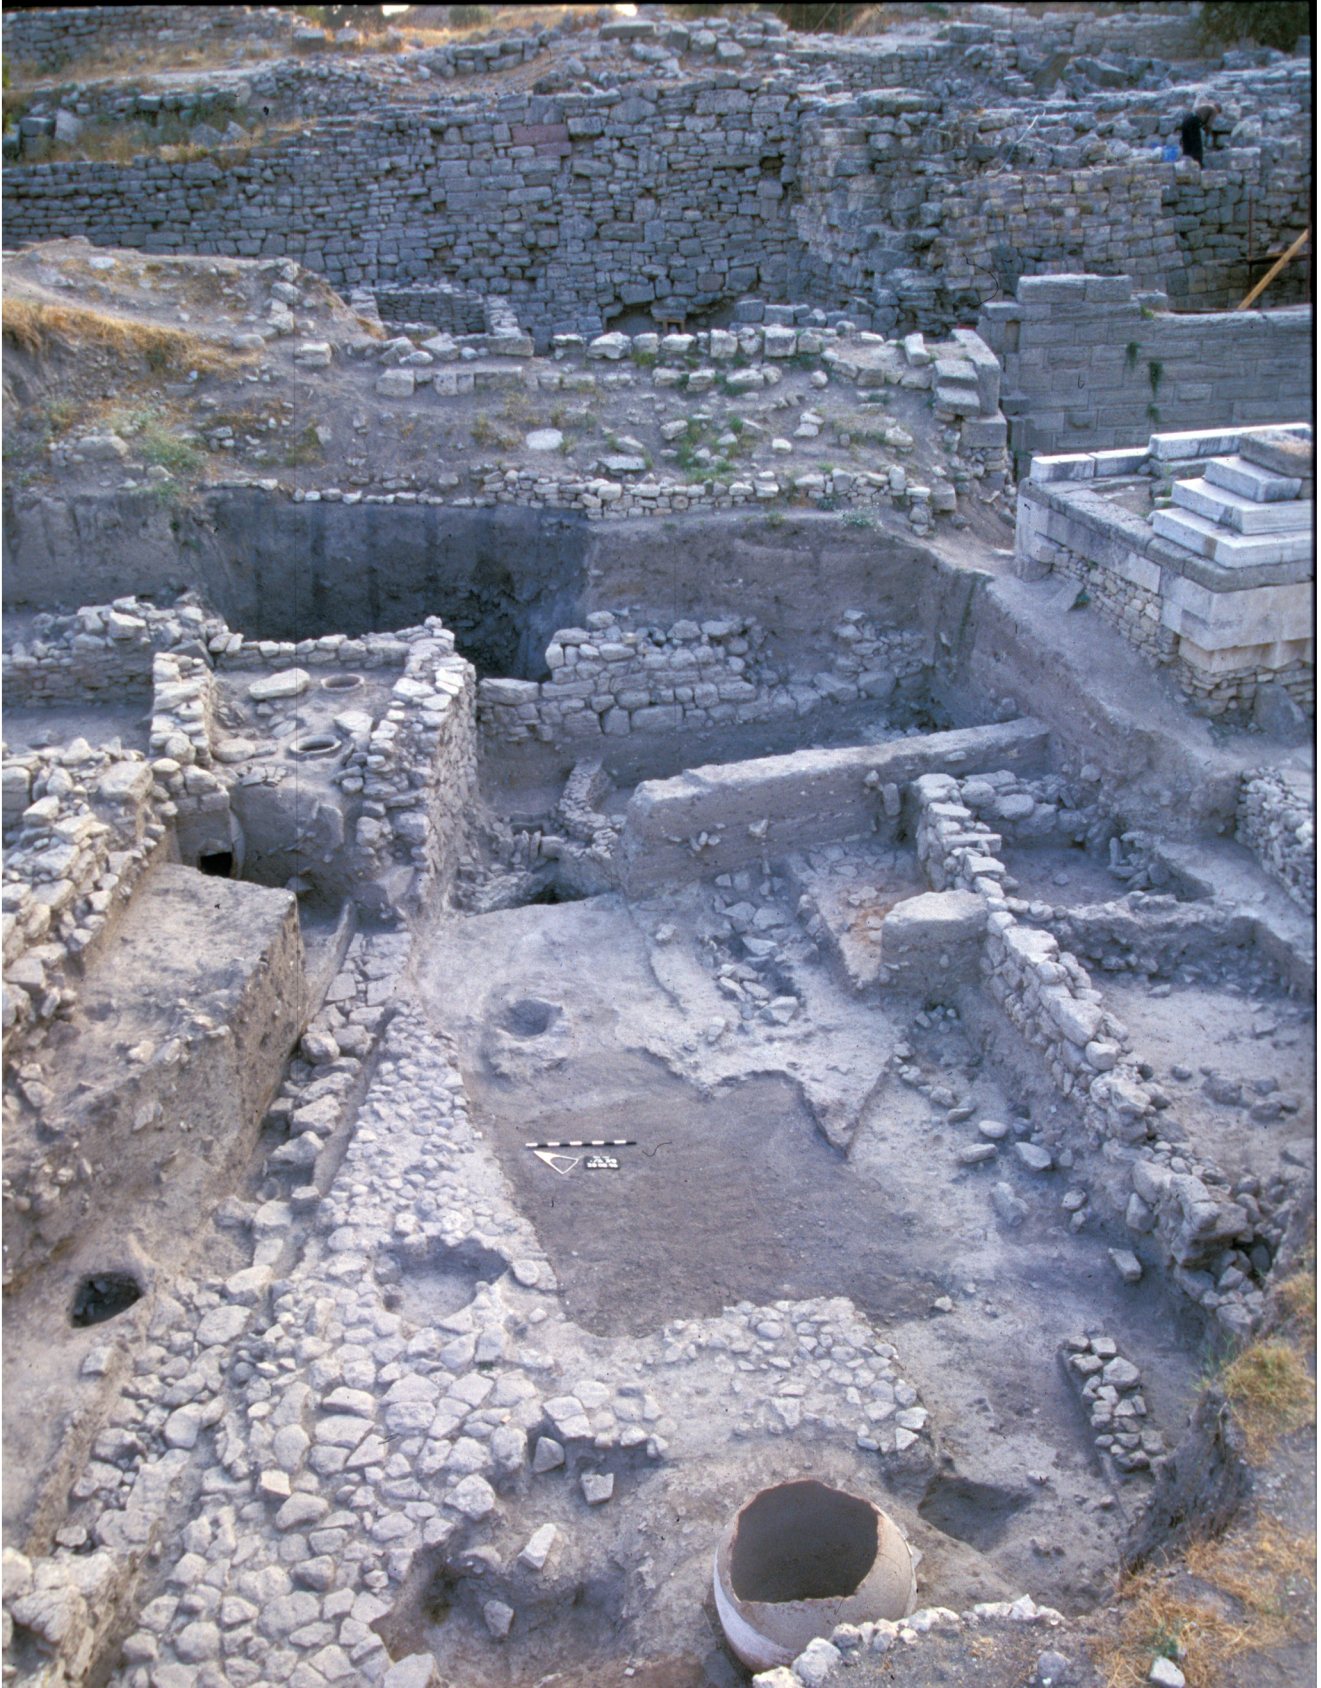
A. View of the Pithos Room (on the left), the Street Area with the „Blocking wall“, the South House (on the right). In the middle, the re-filled Blegen sounding, in the background Roman Grandstand and Gate VIU. (Dia 24244)

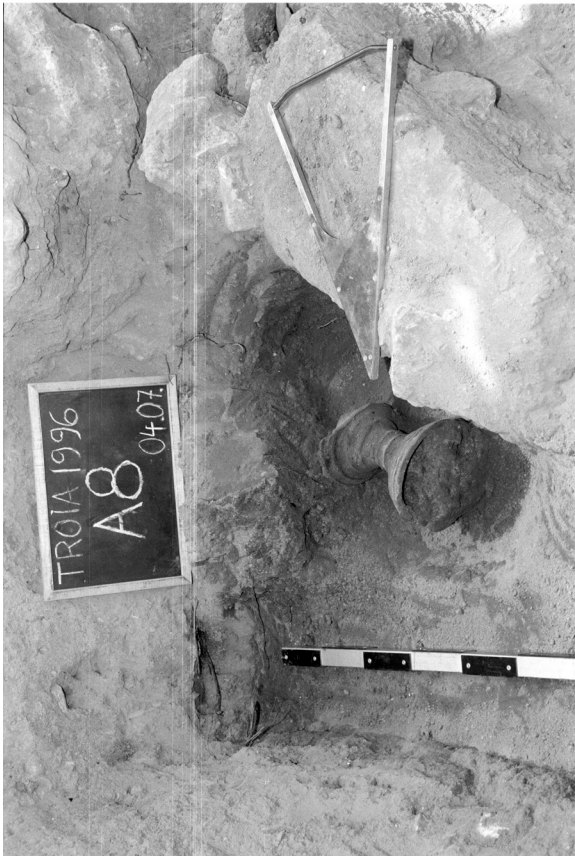
A. View of the thymiaterion as found in situ.
(SW 96/61/3)

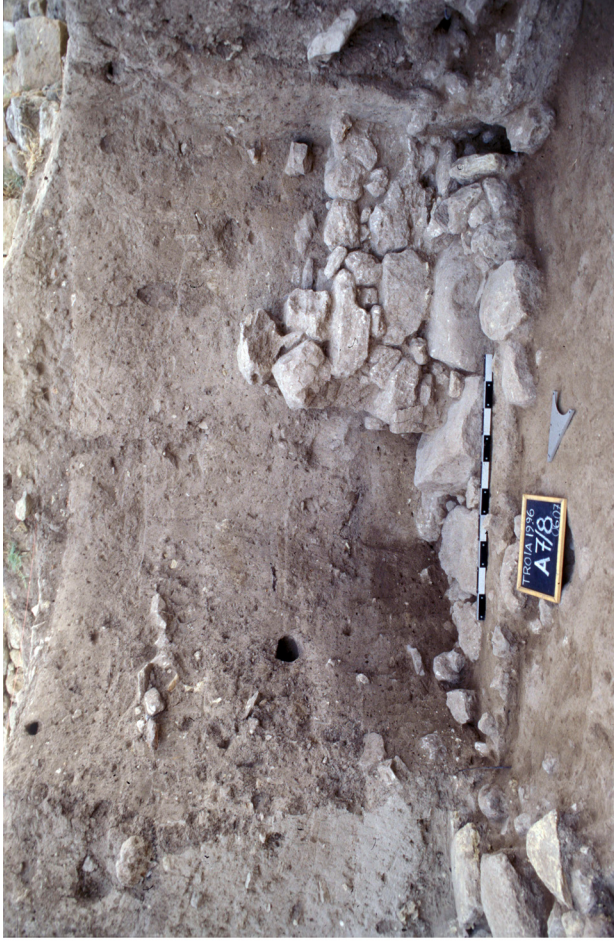
B. Thymiaterion pit cut into the „Blocking wall“ after partial exposal.
(Dia 24112)

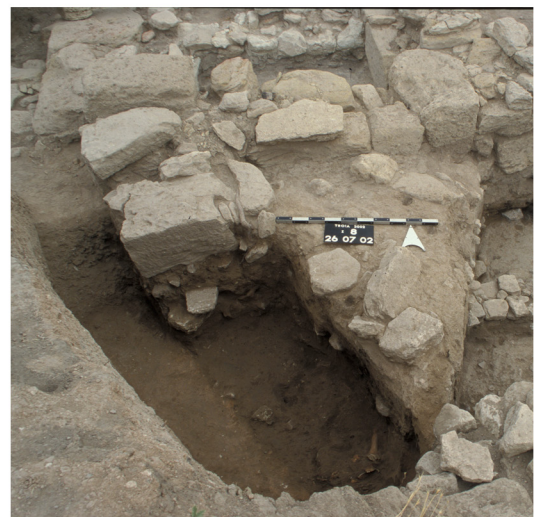
F. Presumed continuation of the Unattributed Wall Fragment abutting the Porch Wall (above the scale). The west wall of the Pithos Room robbed out, with the foundation deposit starting to be visible as the big bones in the deep right corner. On the left side of the sounding, the robbing trench of the Hellenistic Mosaic Building. (Dia 49682)

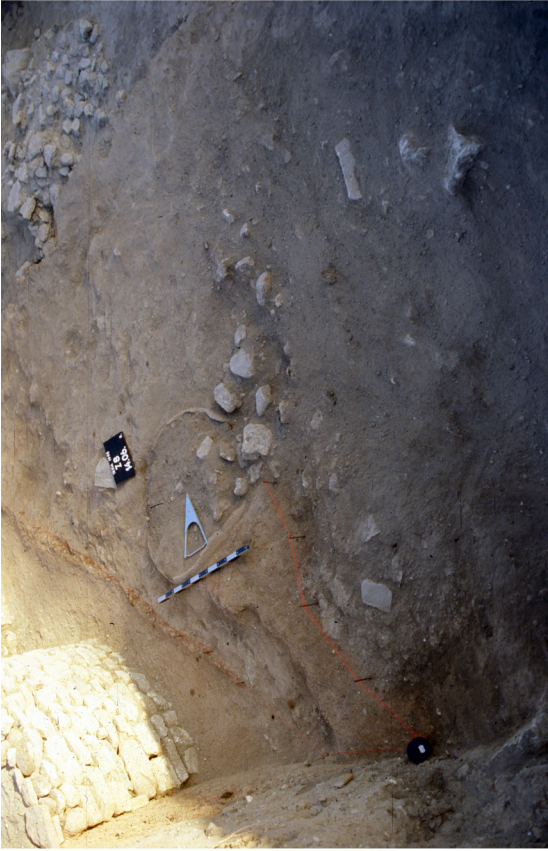
A. The „Big Pithos“ in time of its discovery. Protecting wall constructed for the Mosaic Building on the left. (Dia. 21251)

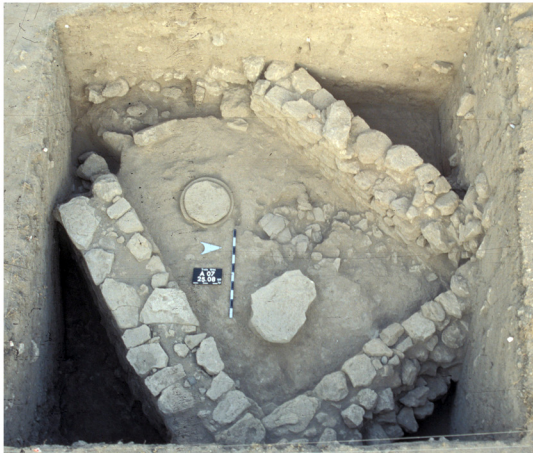
D. First Protoegeometric pit with its stone fill visible in the background profile. Another pit fill of small stones and broken pithos sherds to the right of scale. (Dia 16909)

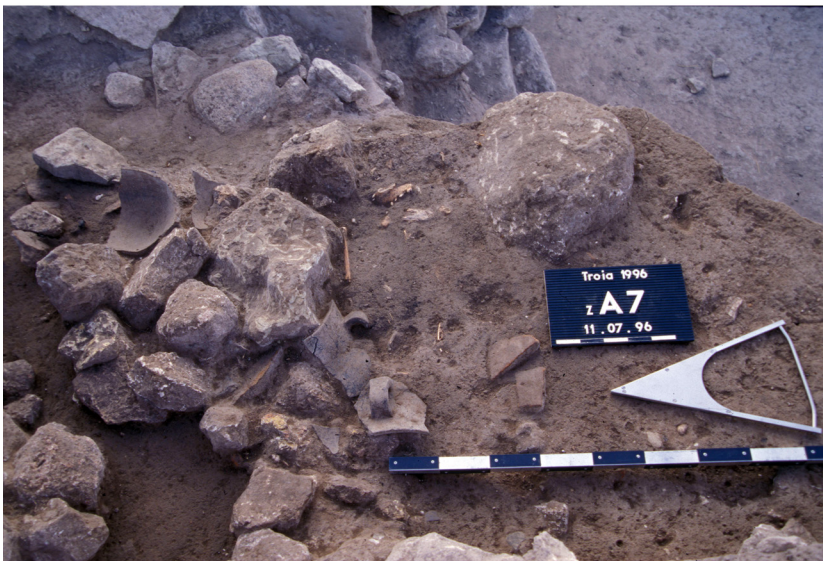
F. Fill of stones, broken pottery and bones belonging to the First Protoegeometric pit in the Pithos Room as found in situ. (Dia 24016)

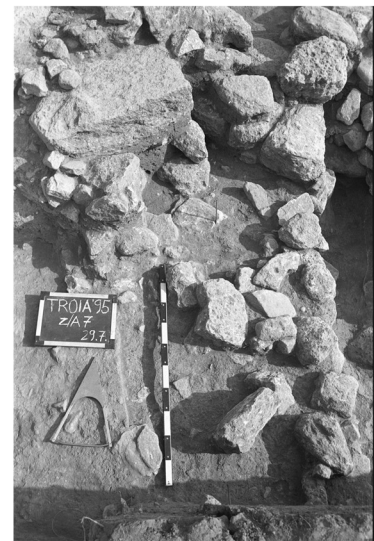
G. Scattered stones near the junction between the „Oddly oriented wall“ and the Main Room. Slightly higher level than in the previous photograph. (SW 95/37/8)

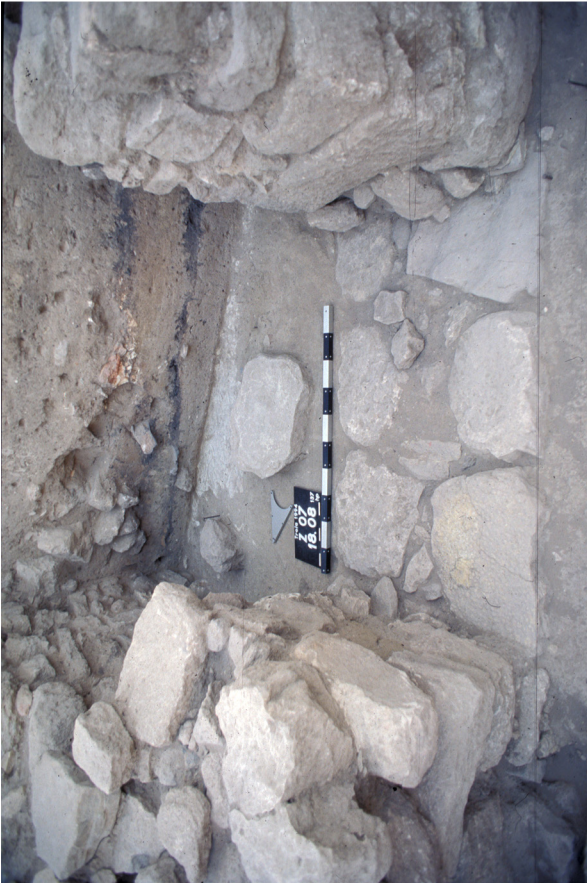
A. Threshold stones of doorway between the Central Room and the South Room. Lime floor of the South Room and two burnt layers visible in the profile. (Dia 16798)

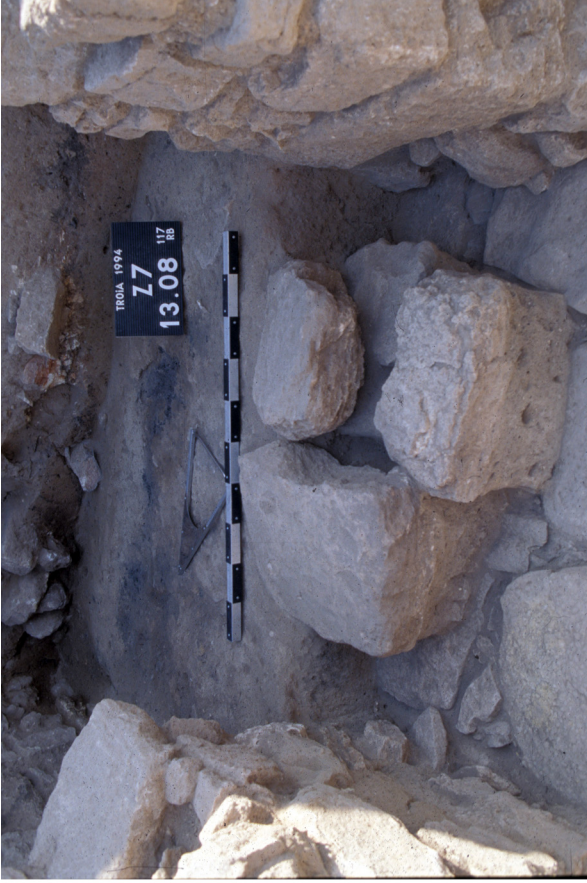
B. Stones in the doorway between the Central Room and the South Room. (Dia 16871)

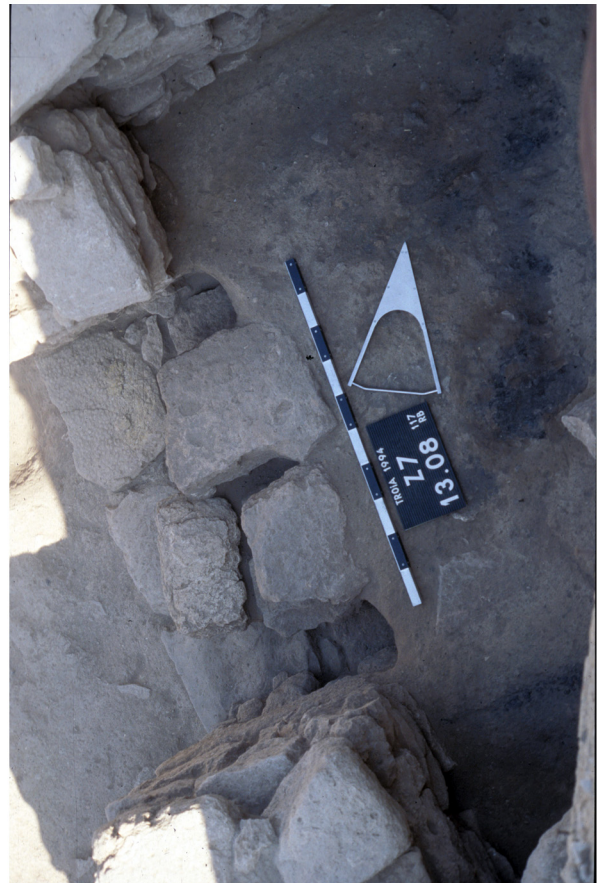
C. Burnt layer in the South Room and the stones in doorway, (Dia 16872)

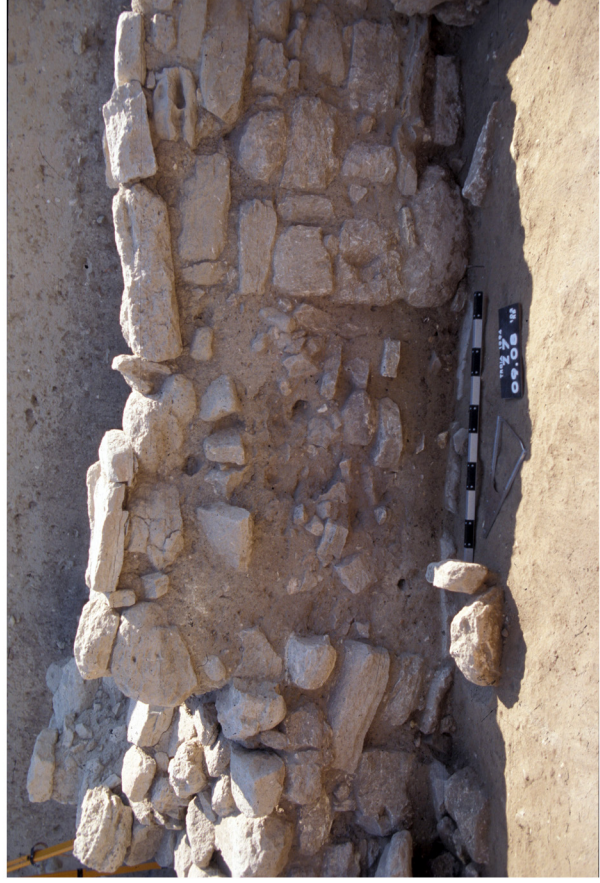
D. Doorway between the South Room and the Central Room blocked by fallen stones and overbuilt by a Geometric wall. (Dia 16775)

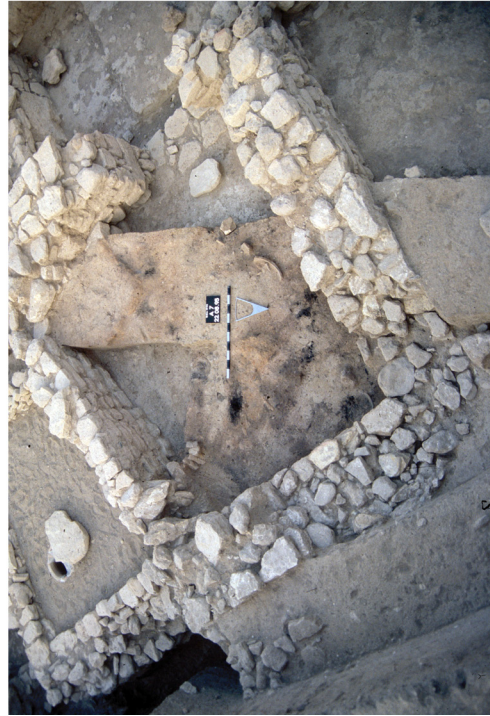
C. South Room, lower burnt horizon and the stone fill of the pit disturbing the wall between the South Room and the Pitthos Room. (Dia 22738)

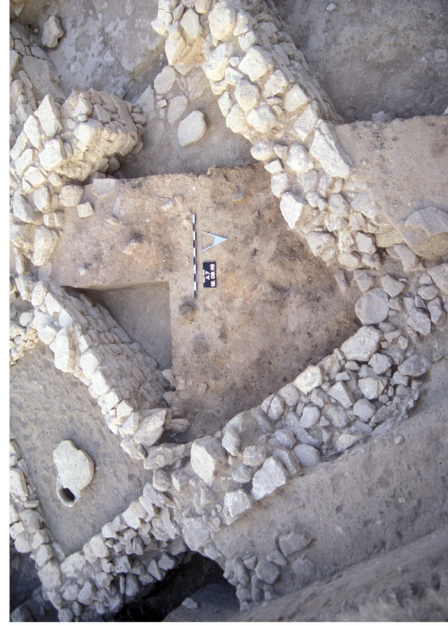
D. South Room, upper burnt horizon and the stone fill of the pit disturbing the wall between the South Room and the Pitthos Room. (Dia 22627)

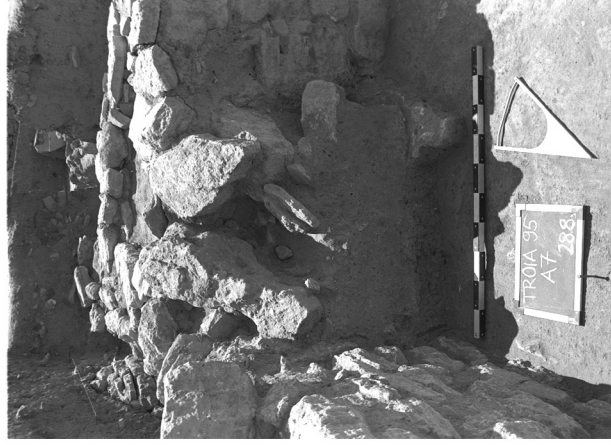
E. Loose stones in the pit between the South Room and the Pitthos Room. (SW 95/77/8)

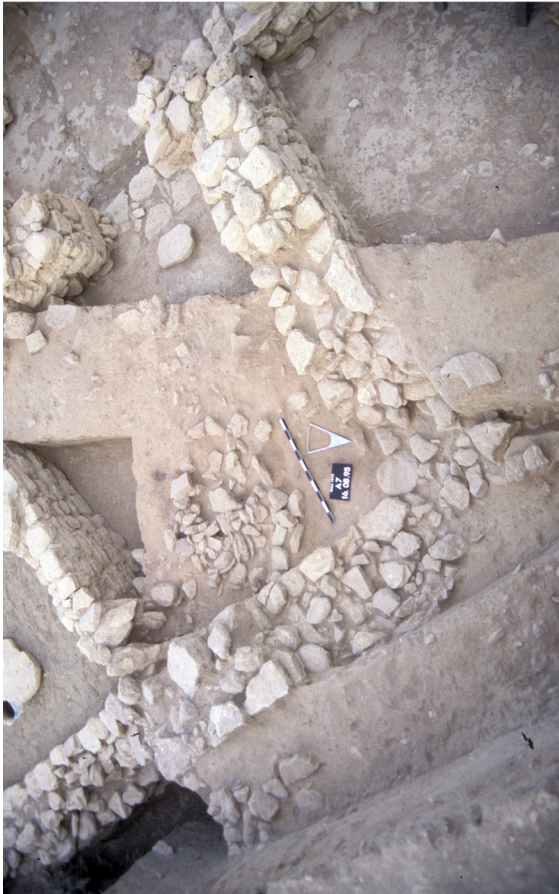
A. South Room, stone concentration cut into the debris of Troy VIIa. The disturbance in the foreground corner was caused by a Troy VIII pit. (Dia 22548)

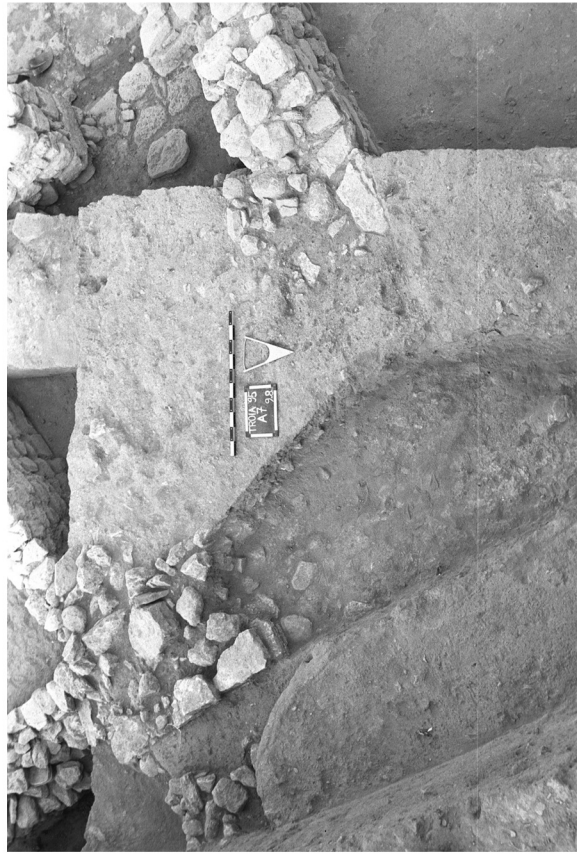
B. Troy VIII pit cut into the walls of the South Room. The deposits inside the room contained Troy VIIIb and Protogeometric pottery with many small finds. (SW 95/46/18)

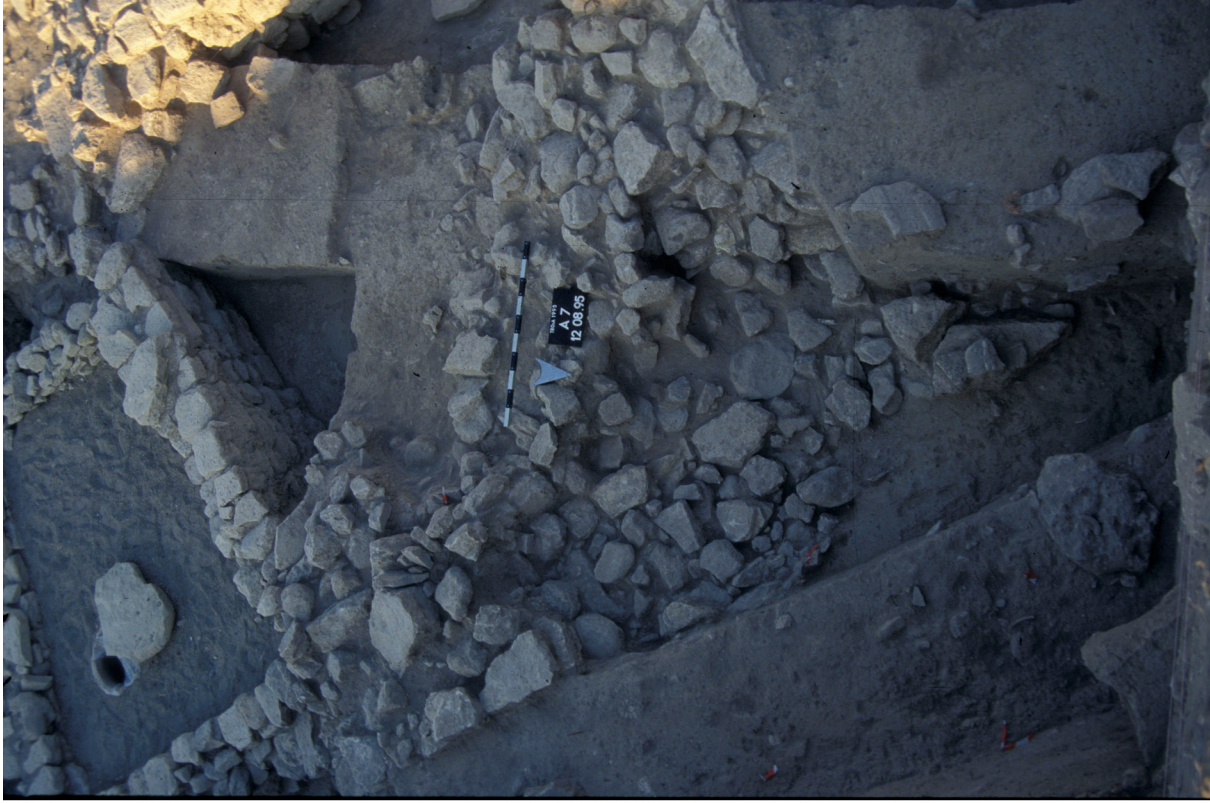
C. Stone fill in which numerous small finds have been found. The lower corner is disturbed by a Troy VIII pit. (Dia 22444)

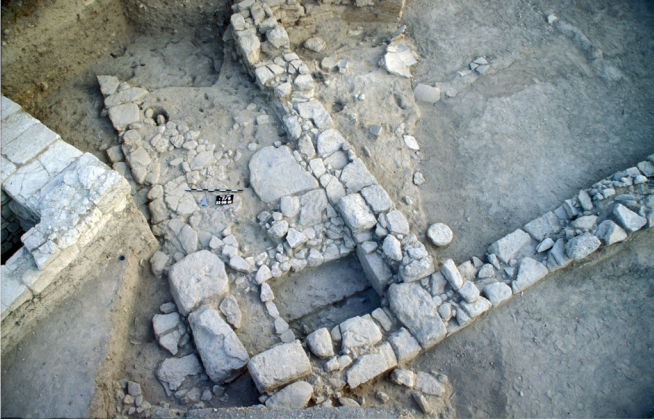
A. Porch Area of the Terrace House. Hellenistic Temple B on the left. The area on the right is refill of soundings from recent excavations. (Dia 47034)

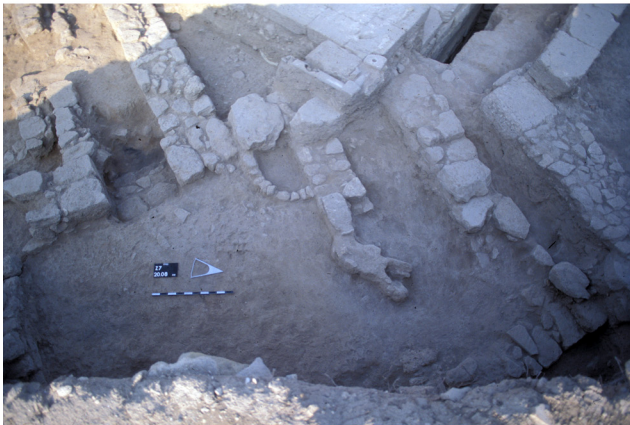
C. The North Room, deposits under the burnt layer, slightly above the floor level. (Dia 13548)

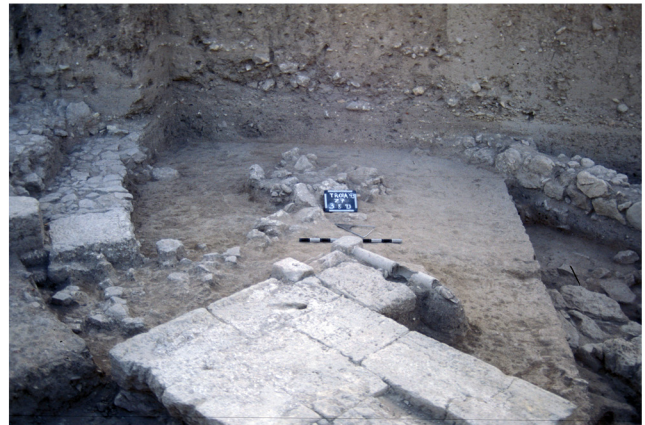
D. Stone pit above the ruins of the North Room. The surrounding deposit yielded many painted Protogeometric sherds. In the foreground, the corner of Temple A. On the left, Hellenistic pavement. (Dia 13495)

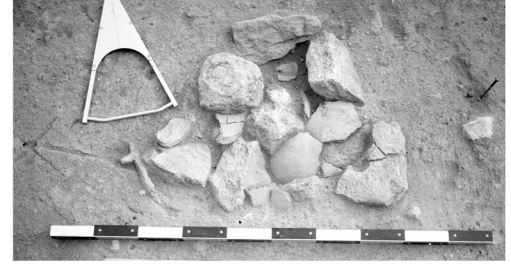
B. Pit with cooking pots with fill of stones and broken sherds. (SW 94/112/21)

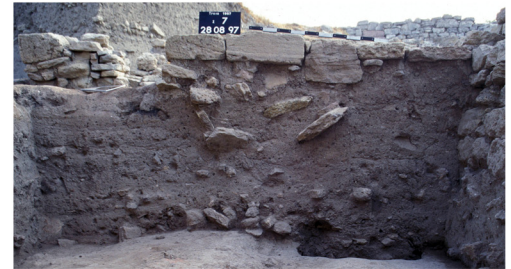
D. „Pit under the Orthostate wall“ in the profile. View from the west. (Dia 29211)

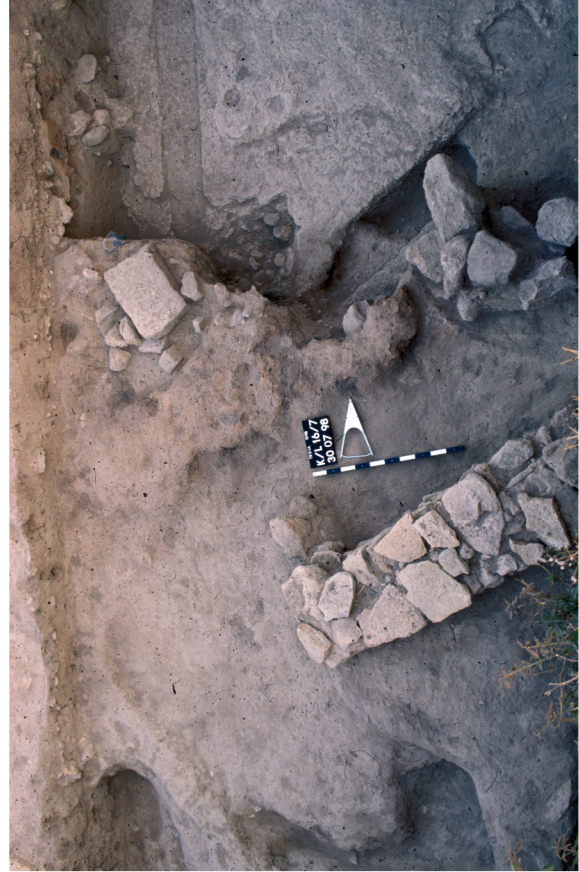
D. Square K/L16/17, the South Pit filled with stones (in the middle foreground), Troy VI wall on the left, rock surface with Troy II palisade on the right, undated stone pit in the middle background. (Dia 35228)

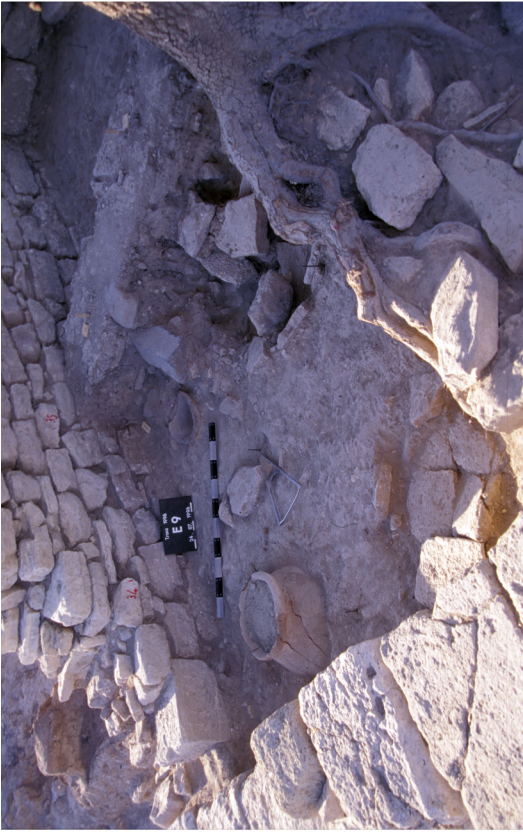
A. Room A, Troy VIIa level with a pithos in southwest corner. Another pithos is still covered with broken stone slabs (middle foreground). The pit near the profile is cut from a slightly higher level. A pithos foot can be seen between the scale and the profile. (Dia 24472)
