POTTERY OF TROY VIIB

CHRONOLOGY, CLASSIFICATION, CONTEXT AND IMPLICATIONS OF TROJAN CERAMIC ASSEMBLAGES IN THE LATE BRONZE AGE/EARLY IRON AGE TRANSITION

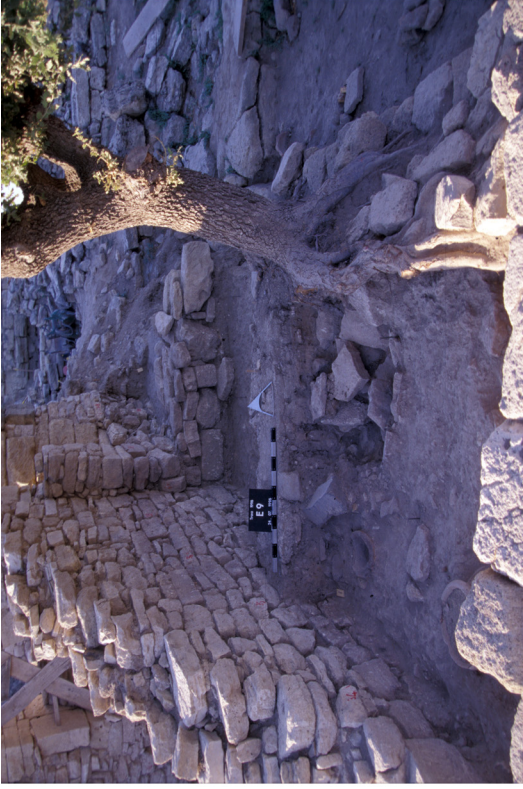
B. House 761 and its predecessor - Room A. View from the citadel wall. Troy VIIa horizon with the pit filled with fallen stones in the profile. A pithos foot can be observed in front of the profile, between the pit (on the right) and the wall (on the left). (Dia 24474)

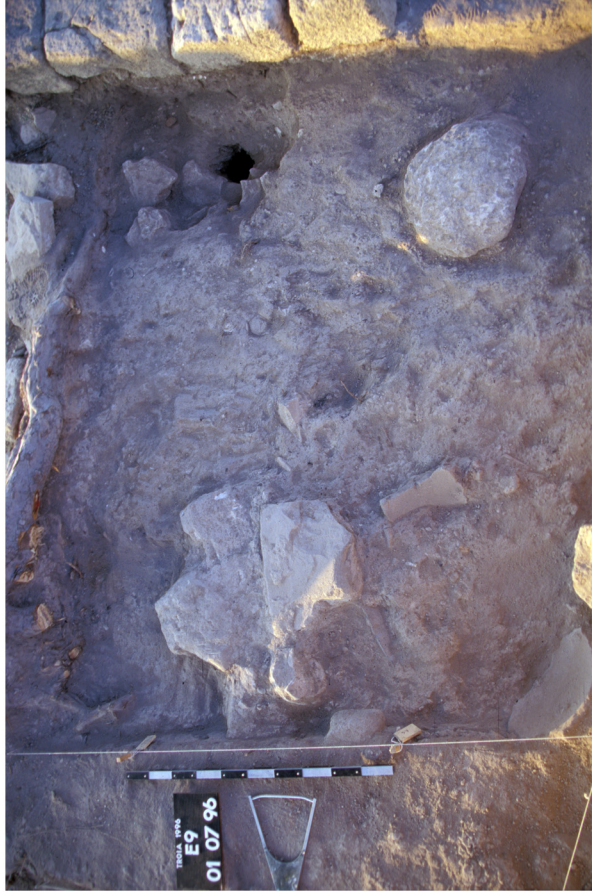
C. Room A/House 761, the pit in the middle (Troy VIIa/VIIIb1). The stone in the right foreground is placed above the mouth of the pithos visible in pictures A and B. The big sherds in the foreground left belong to the same pithos as the foot visible on pictures A and B. (Dia 24417)

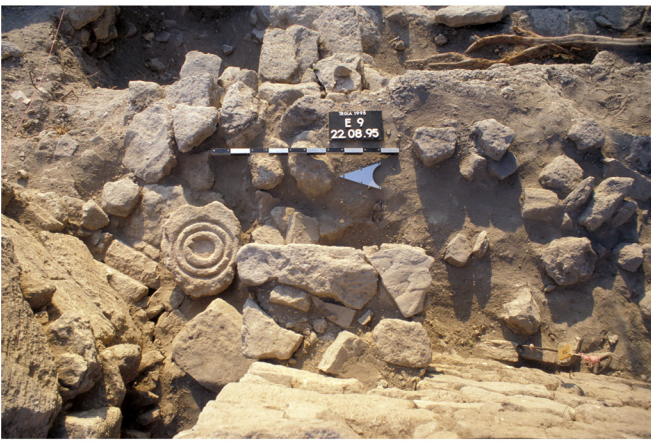
C. House 761. Entrance to the house with the presumed pavement of Troy VIIb2 street on the left and with refuse layers dating to the same period inside the house. The carved stone with concentric circles was found laying face down. (Dia 22757)

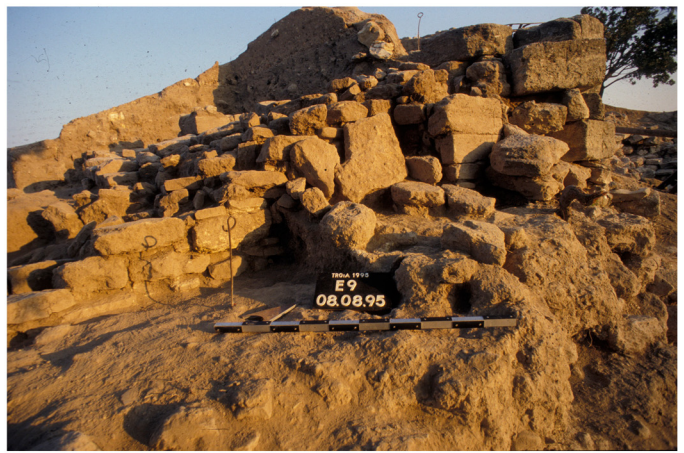
D. House 761. The uppermost preserved features inside the house. Troy VIIb2 probably contaminated with later sherds due to proximity to Archaic walls and also to eroded mound surface. (Dia 21581)

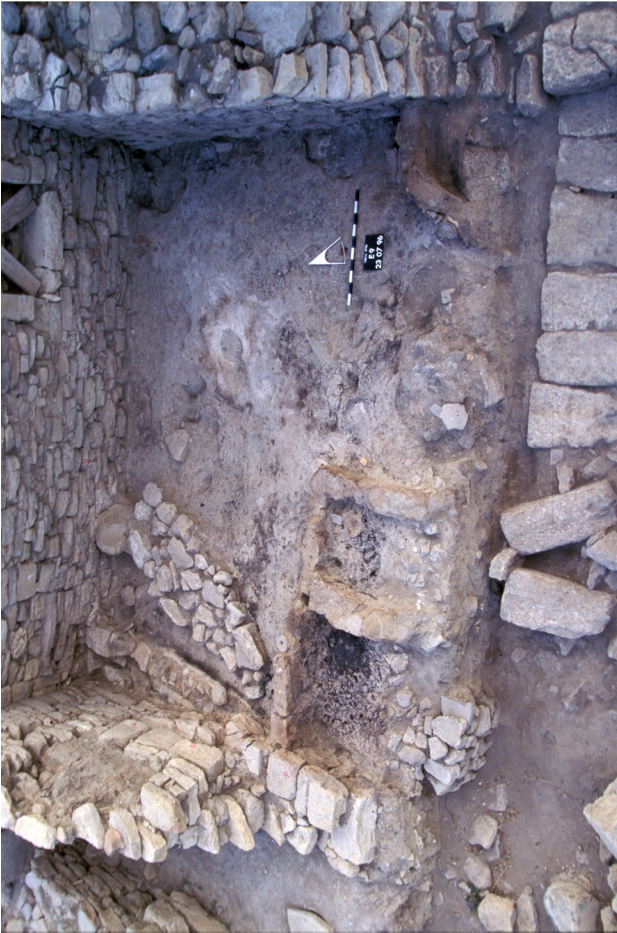
A. Room B, burnt floor and clay bins of Troy VIIa phase. The flat stones concentration in the corner belongs most probably to the Troy VIIb1 phase subfloor packing. (Dia 24448)

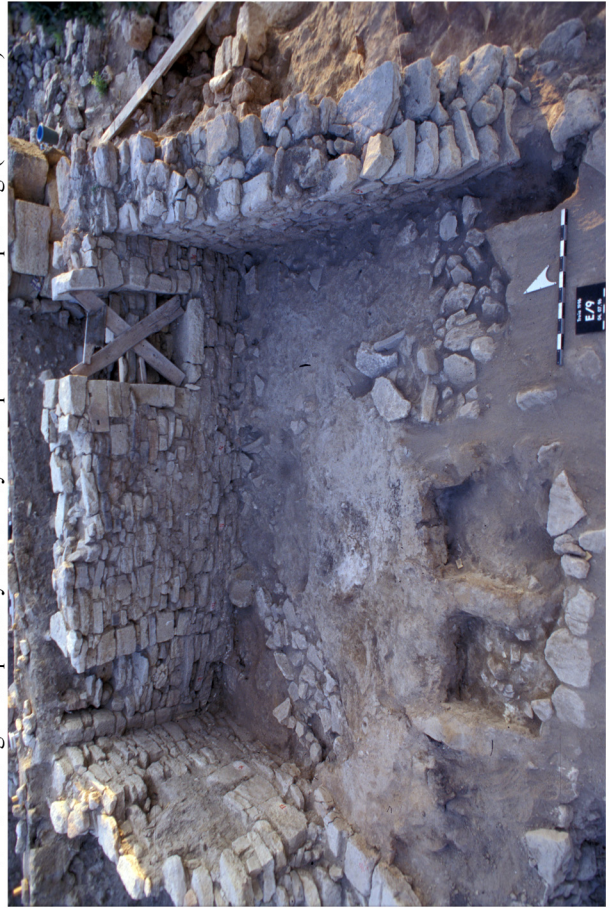
C. Room B, remains of Troy VIIb1 floor (in the middle, above the clay bins). The stones belong to the Troy VIIa destruction and to Troy VIIb1 subfloor packing. (Dia 24424)

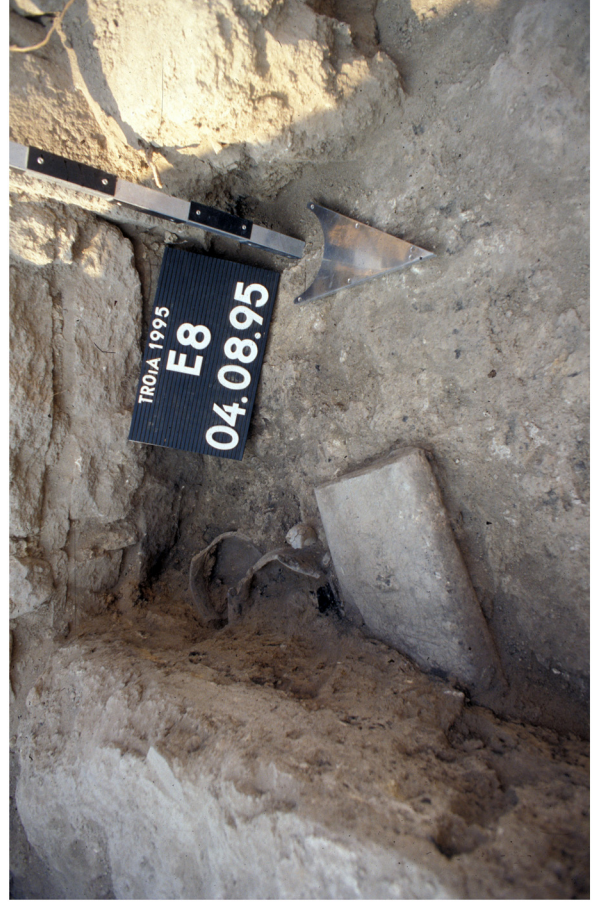
D. Room G, Knobbed ware cups found in situ on the Troy VIIIb2 floor. (Dia 21233)

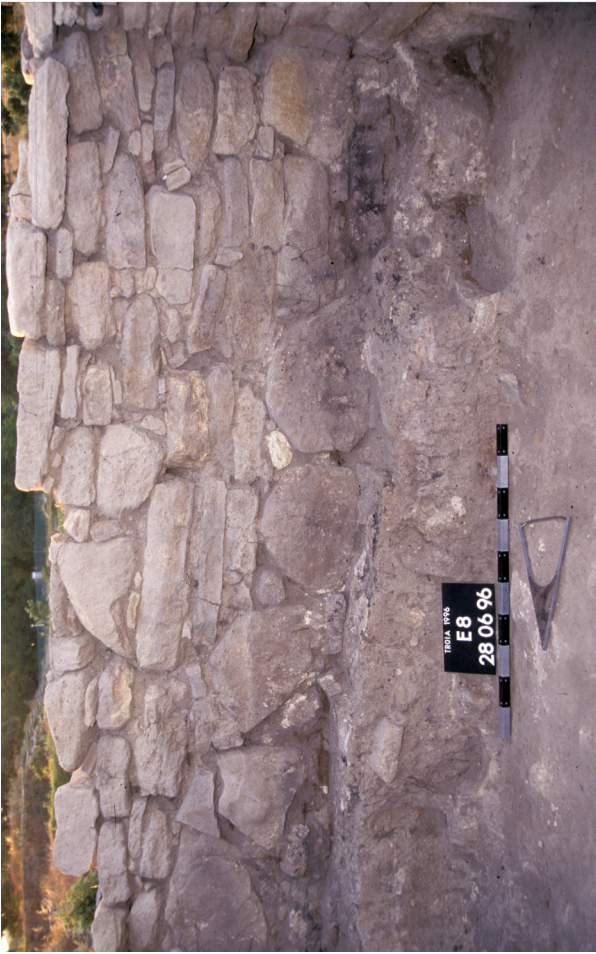
A. Room G, division wall to House 768 with band of black fire traces. Remains of whitish Troy VIIIb2 lime floor can be seen atop of the small profile along the wall. (Dia 24362)

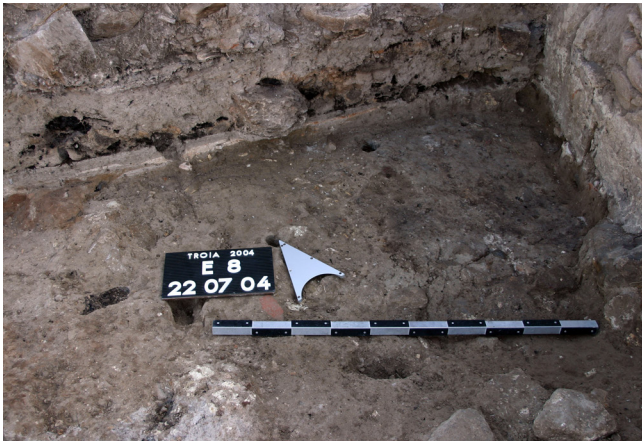
A. Room I, Situation below the Troy VIIb2 floor. The burnt level above the floor visible in the profile. The orthostate wall on the right is plastered with lime. (Dig 22380)

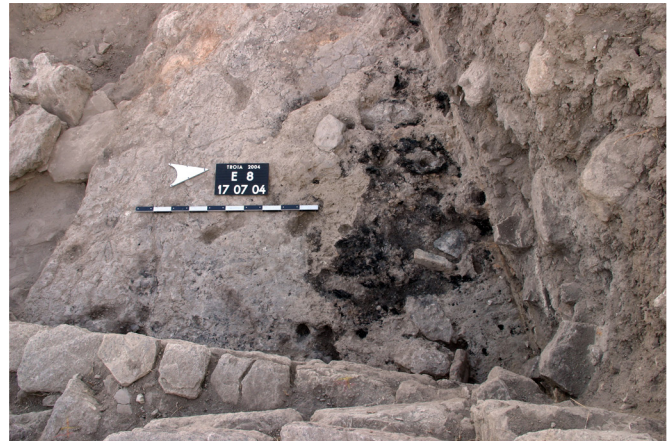
B. Room I, burnt floor level of the Troy VIIb2 phase. (Dig 21793)

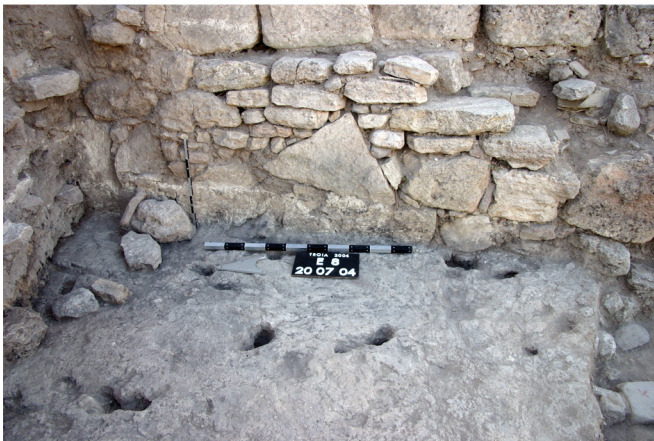
C. Room I. Floor of Troy VIIb2. The lower part of the orthostate wall is plastered with white lime. (Dig 22050)

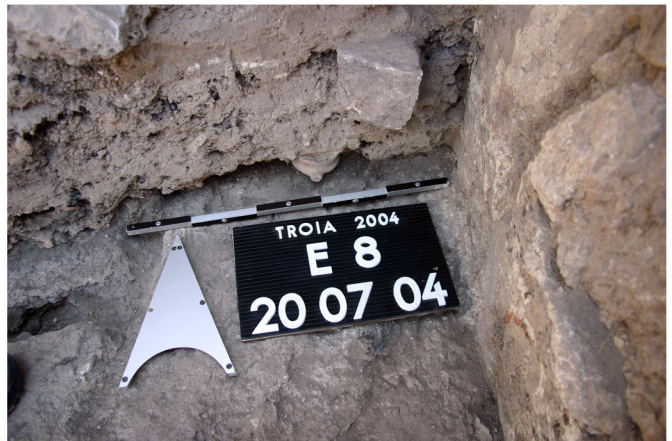
D. Room I. Detail of the Troy VIIb2 floor with a broken Knobbed ware cup in situ. (Dig 22109)

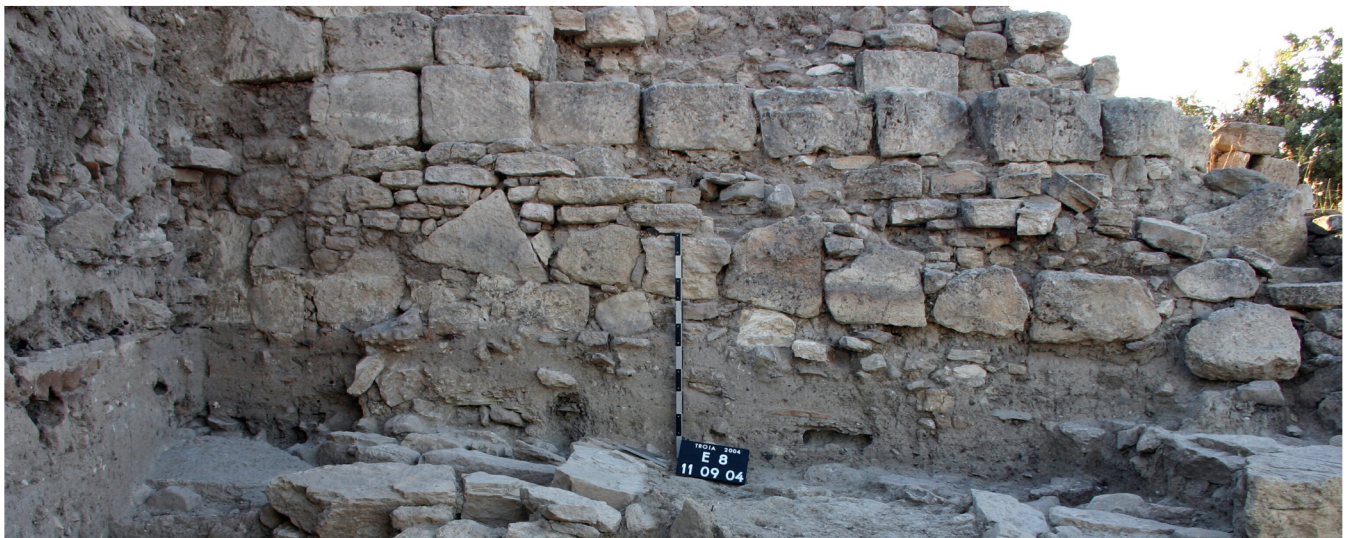
E. Room I. Division wall between Room I and Room H consisting of two orthostate courses above each other. The division wall is superposed by a Roman foundation made of ashlar blocks. (Dig 26169)

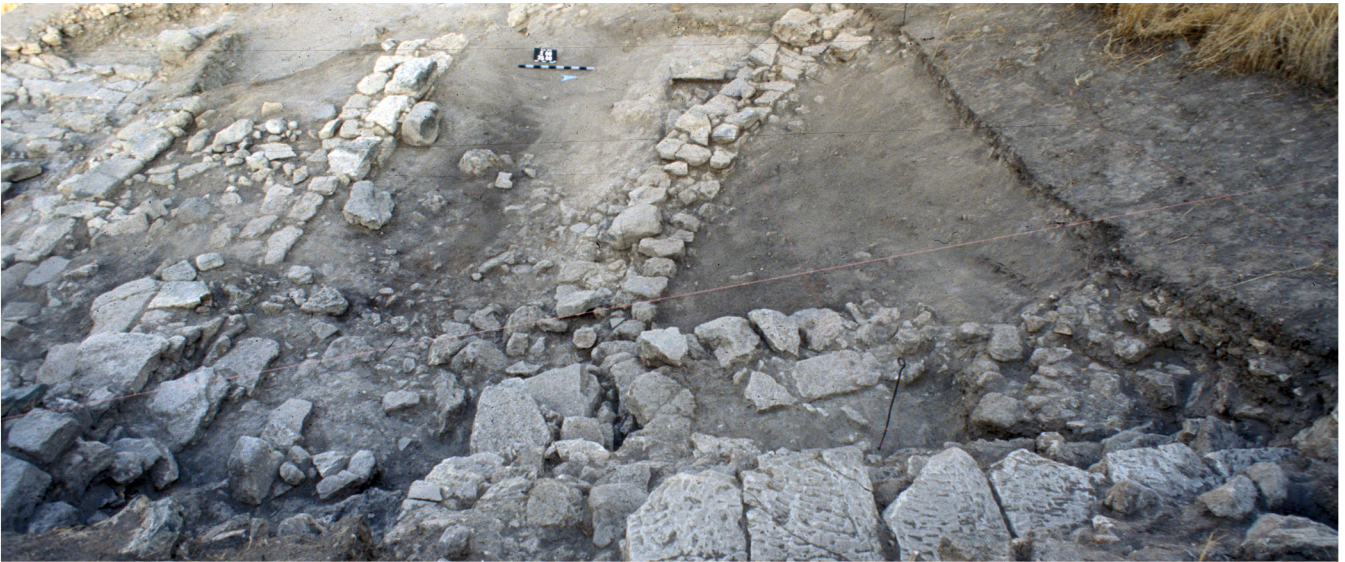
A. Squares E8-9, east part with street in the middle after the removal of vegetation and recent erosion (view from the east). The dark earth in the street area seems to indicate the Troy VIIa destruction. The curving wall running diagonally on the right dates to Troy VIIa. (Dia 17483)

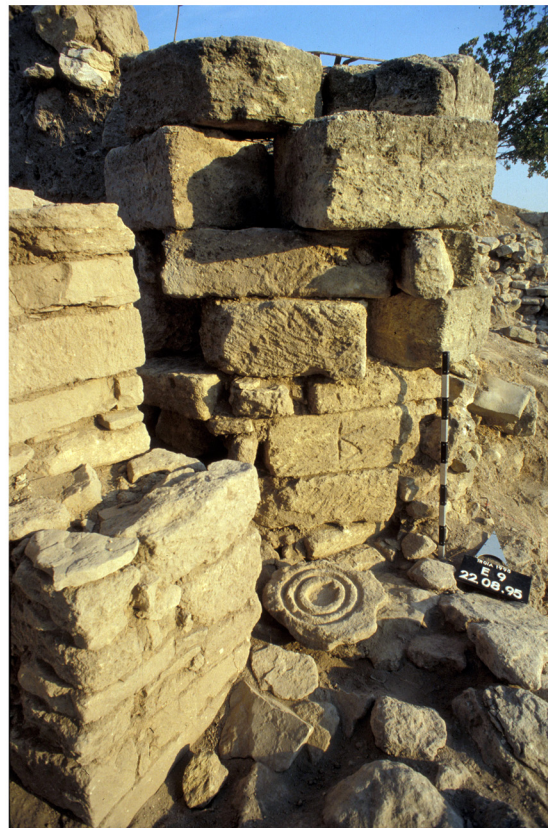
D. Presumed Troy VIIb2 pavement north of the entrance to House 761. The carved stone with concentric circles was found outside of Roman well foundations, lying face down. (Dia 22760)

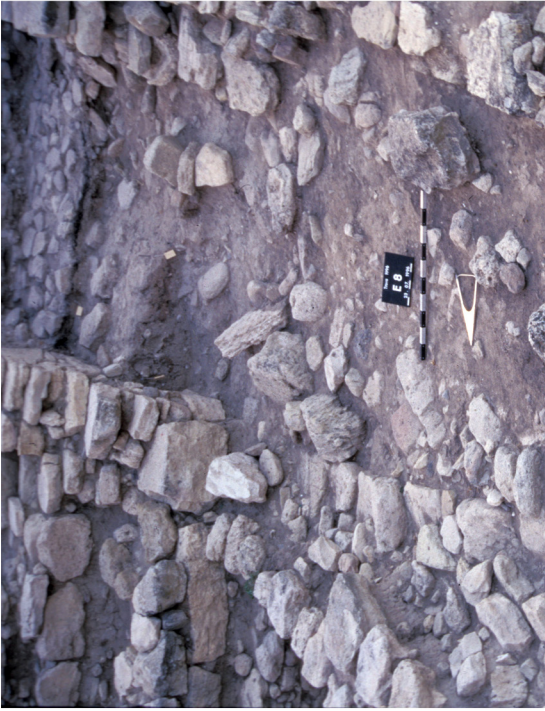
A. Fragment of the Troy VIIIb1 street pavement between Room H (background left) and Room D (background right). A distinct burnt layer visible under the pavement. Troy VI and VIIa walls in the foreground (Dia 24371)

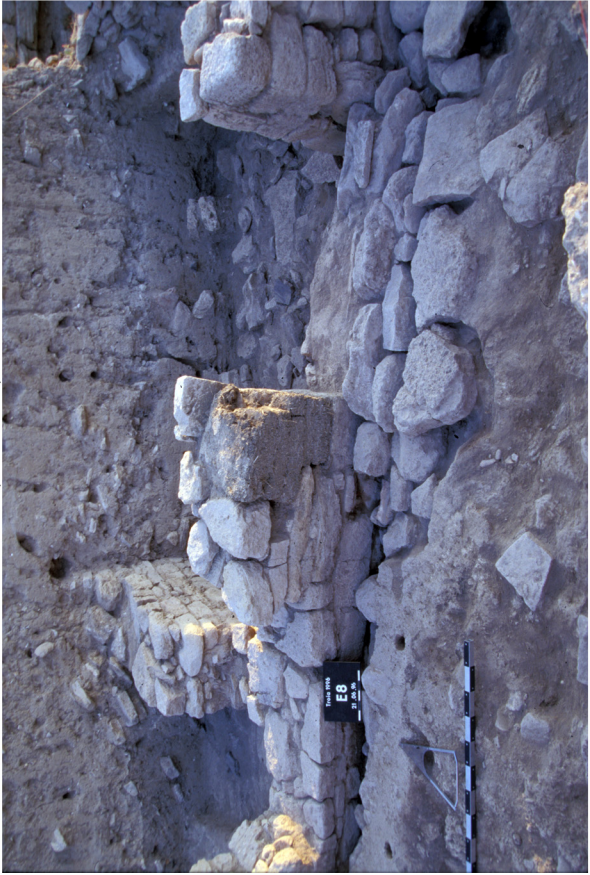
C. View from the Troy VIIIb2 street towards Rooms H (on the left) and G (on the right). The corner between both rooms is disturbed by an Archaic pit. (Dia 24356)

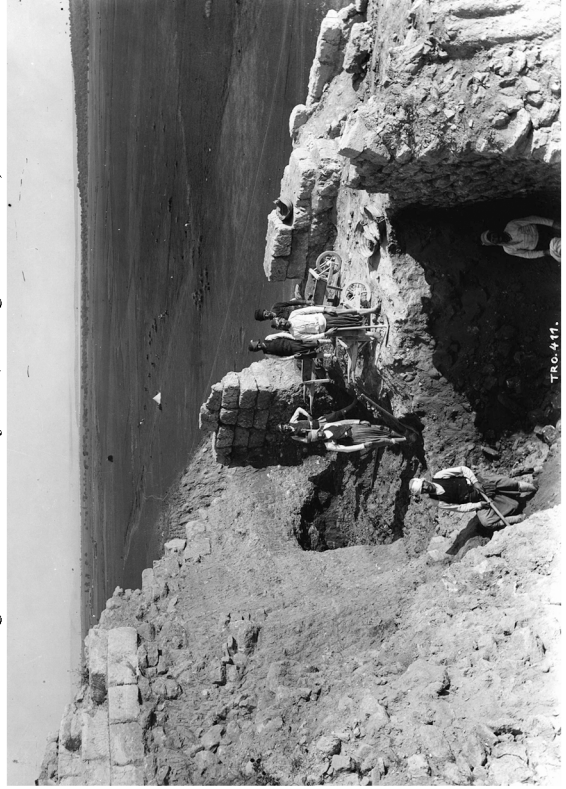
D. Another view of the hollow vault-like space during the excavation (to the left of the workers in the middle). The wall on the right dates back to Troy VII rebuilding operations inside the Northeast Bastion. (Dörpfeld's Photo Archive, DAI Athens, Neg.: D-DAI-ATH-Troja 411, All rights reserved)

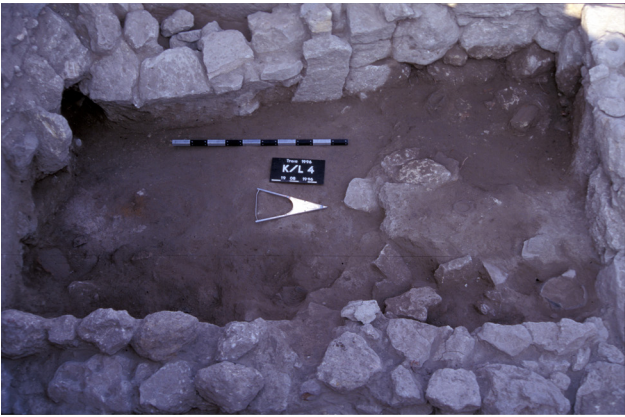
A. Floor of Room 12 with broken pottery sherds and collapsed stones. Rebuilding of the last phase in the background right. (Dia 24724)

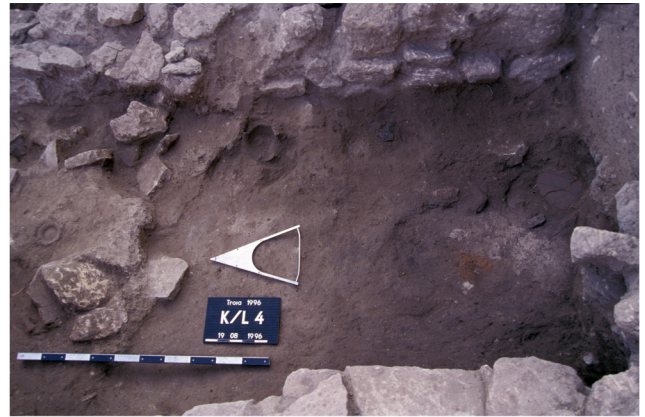
B. Floor of Room 12 with broken pottery and collapsed stones. (Dia 24723)

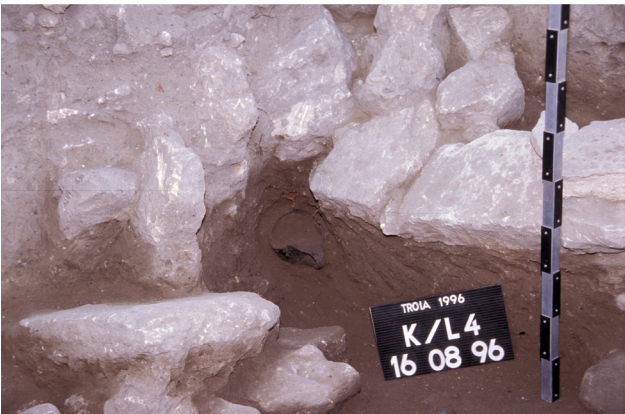
C. One of the broken pots found in Room 12. (Dia 24720)

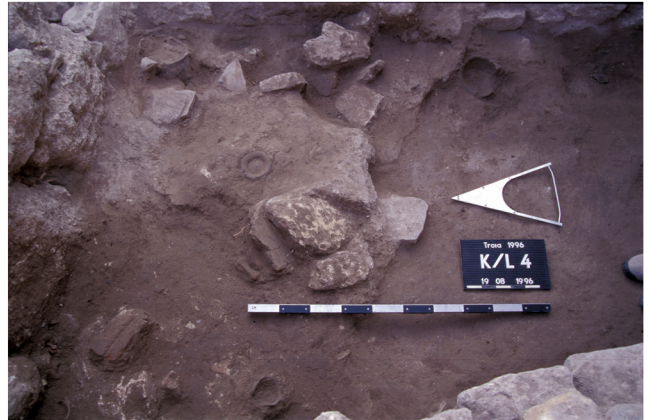
D. Floor of Room 12 in its northeast corner. (Dia 24726)

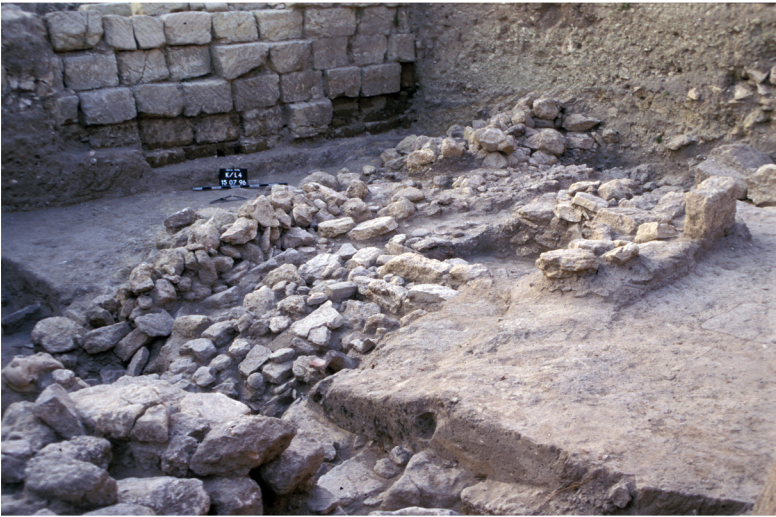
C. Archaic stone tumble (running diagonally through the middle), Roman foundations (background) and Troy VIIa Mudbrick structure (foreground right). (Dia 24592)

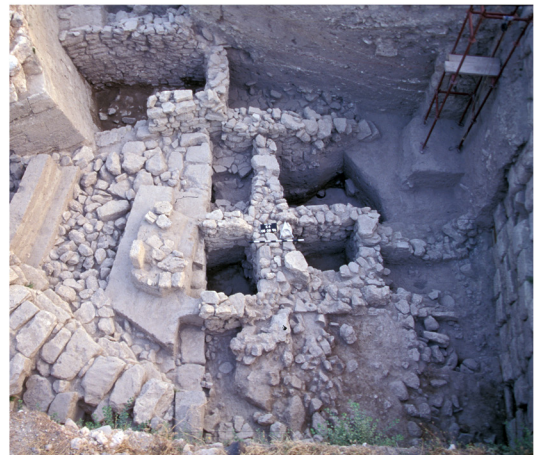
D. View of the Troy VIIb cells in KL4 from the south. Rooms 11 and 12 still covered by debris. (Dia 24682)

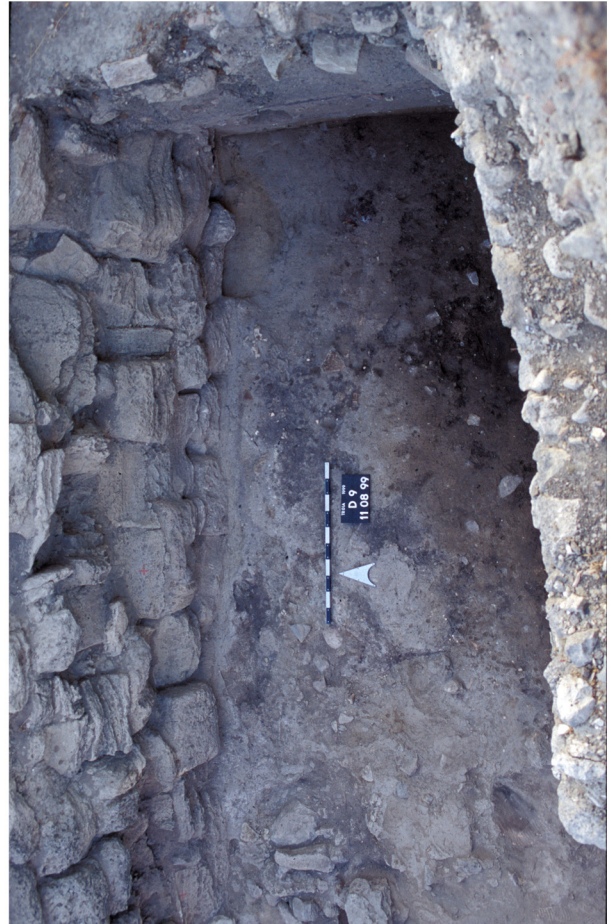
C. D9, Burnt layer above the Protogeometric tumble. (Dia 39391)

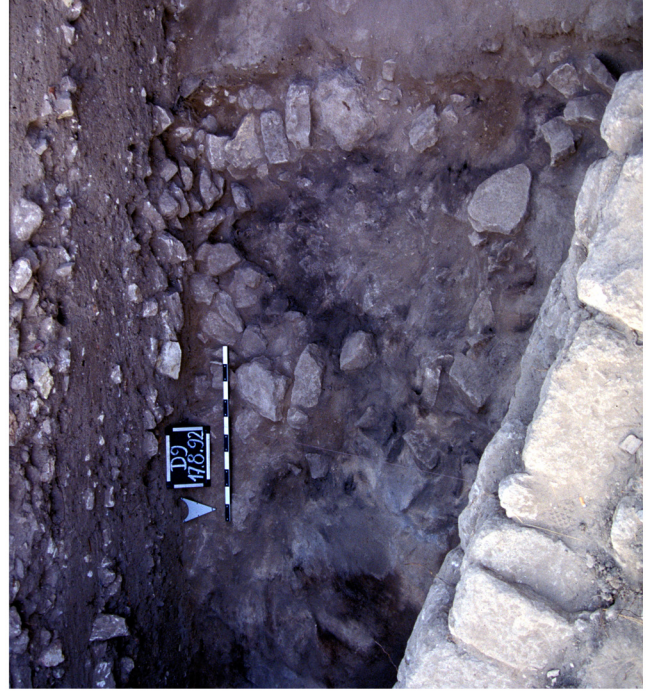
D. D9, Burnt layer above the Protogeometric tumble. (Dia 10275)

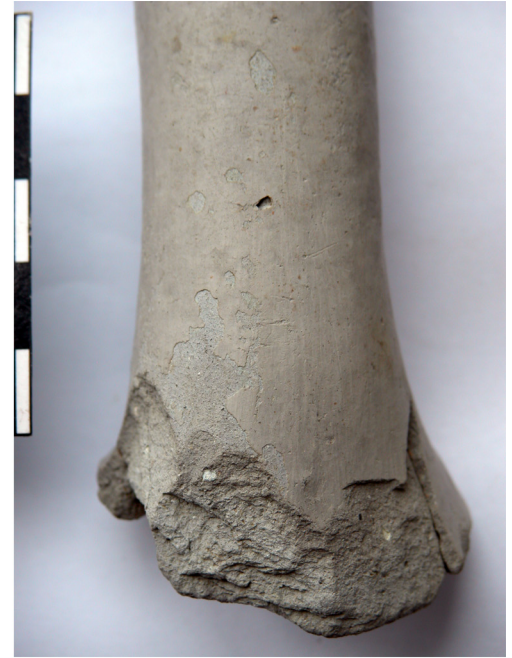
B. Anatolian Grey Ware. Detail of surface treatment of sherd K4.930.15, showing the slip that flakes off.

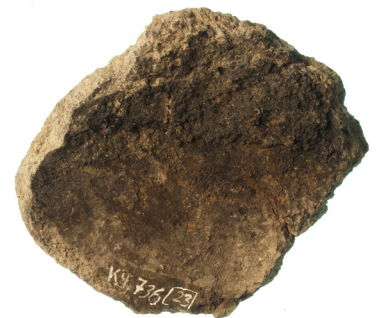
I. Burnt residue in the interior of the
base of Cat. No. 775.

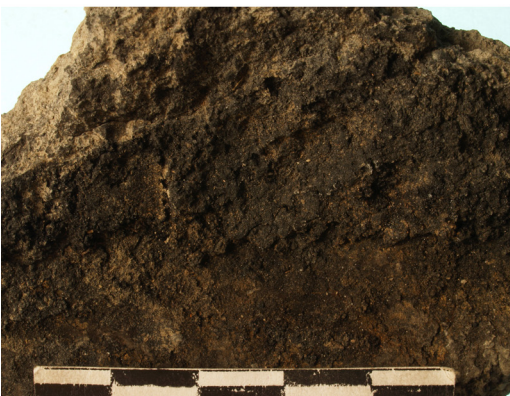
J. Detail of the burnt residue in the interior of
the base of Cat. No. 775.

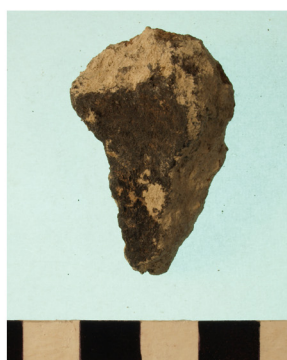
K. Burnt residue inside the
Handmade Coarse Ware
cooking pot, Cat. No. 147.

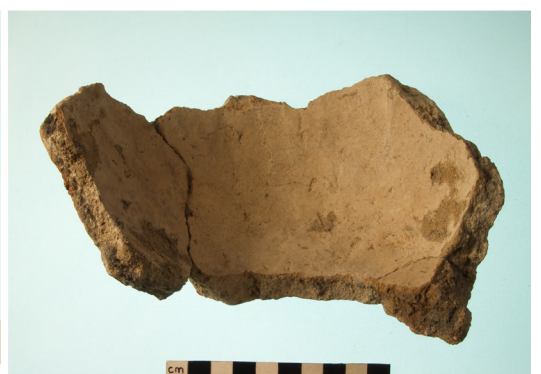
L. Calcareous buildup inside the jar in
Handmade Coarse Ware, Inv. E9.1020.41.
